Traditional American Slate Roofs

Their Anatomy, Maintenance and
Repair

By Joe Jenkins

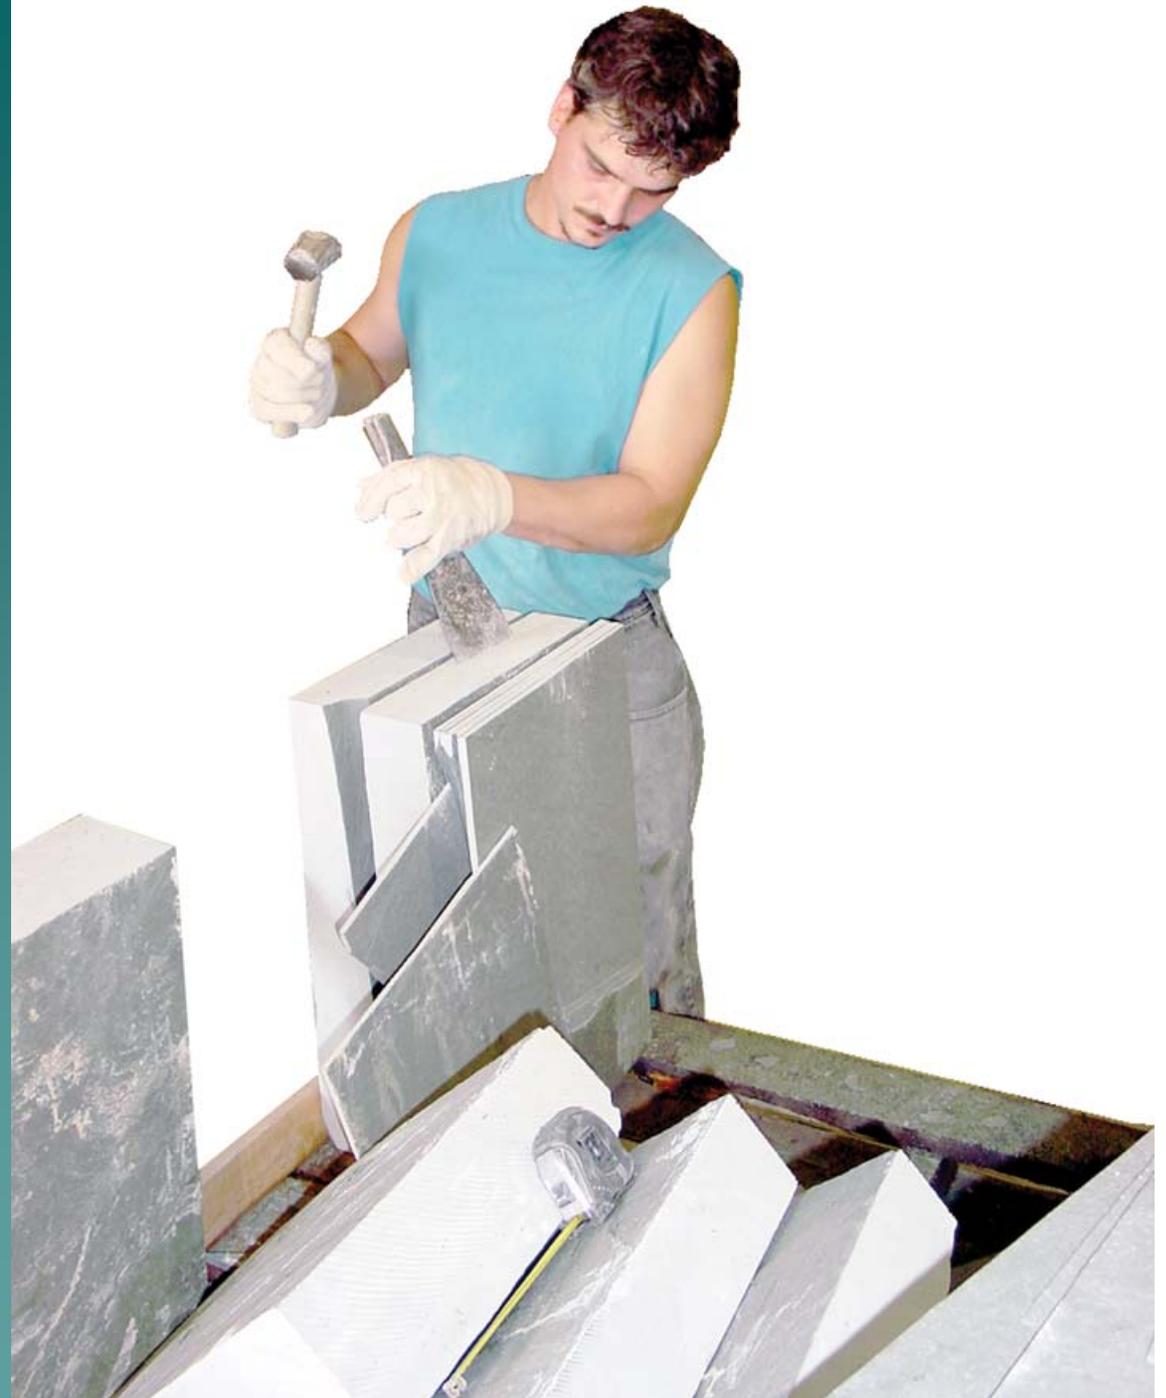
Another
splitter
(Hilltop
Slate, VT)

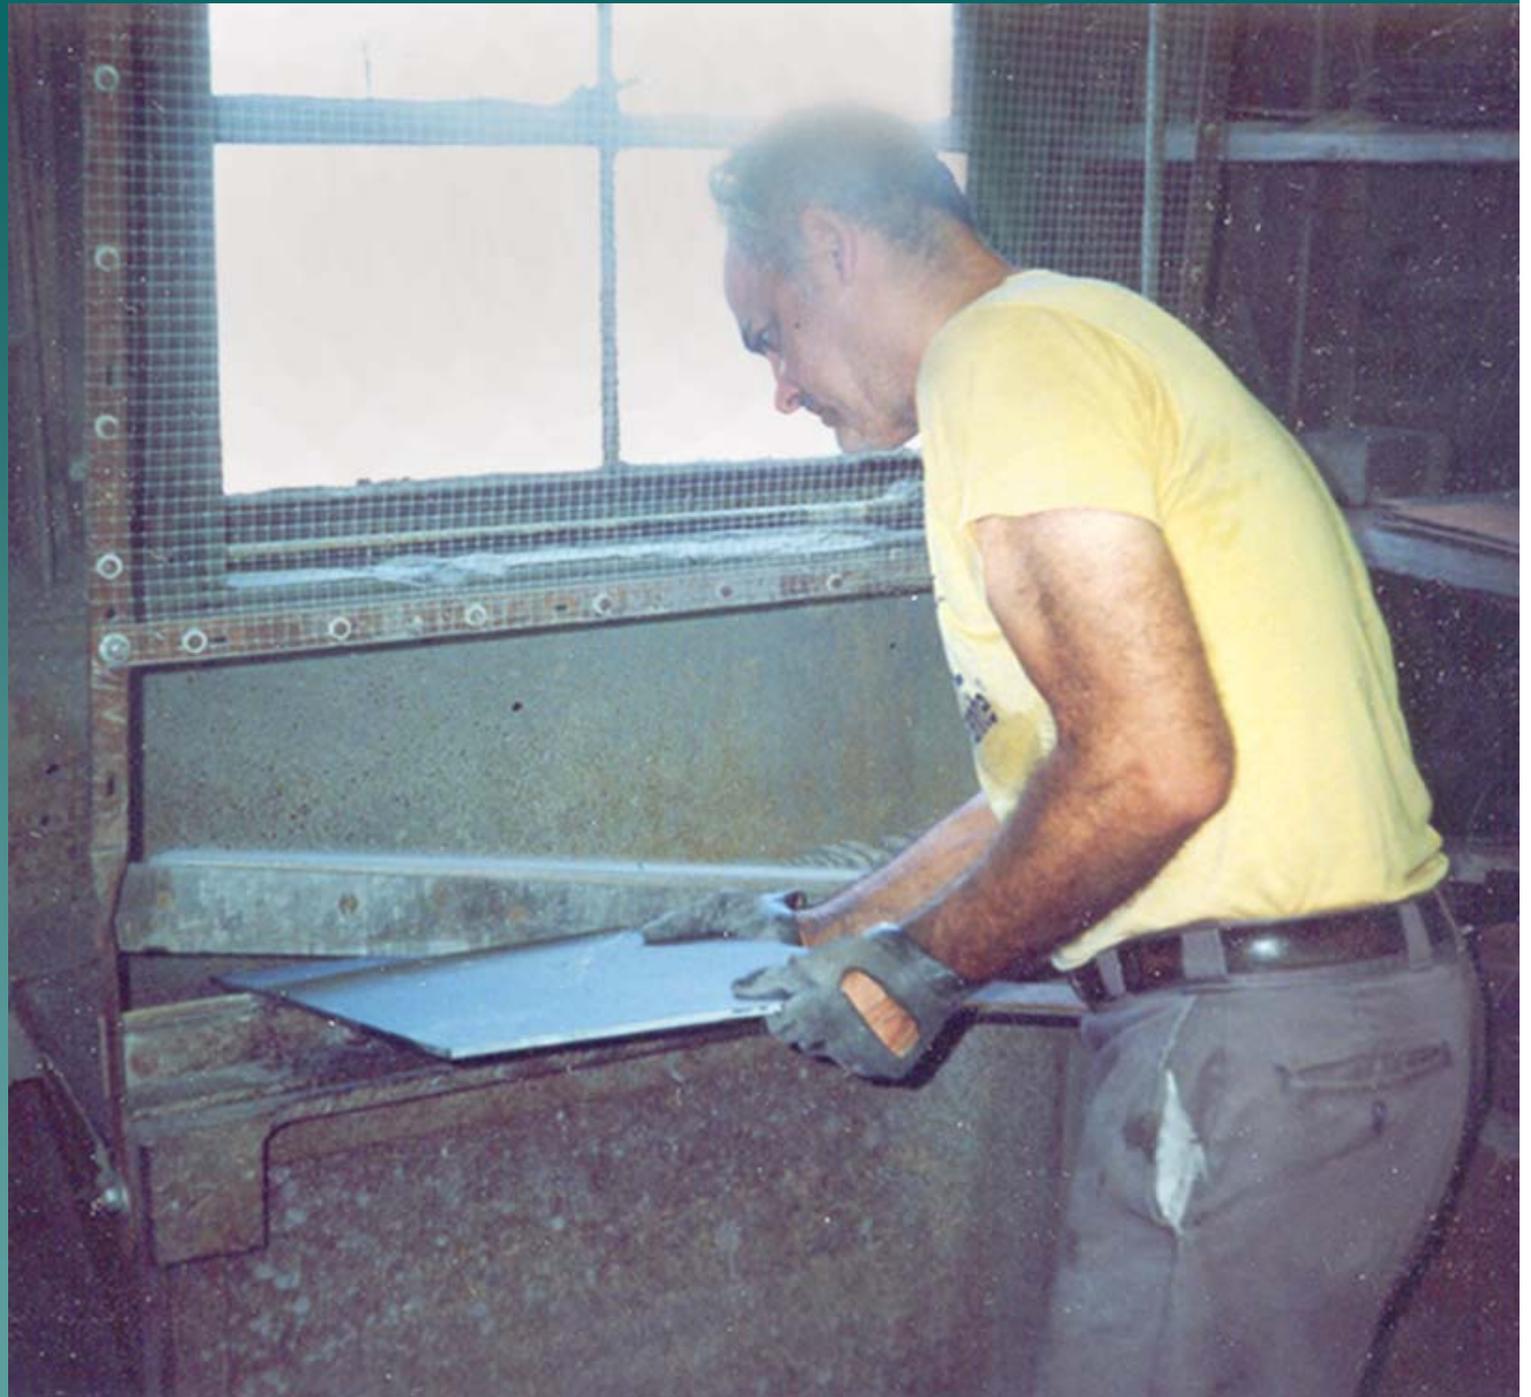
The
edges
are
trimmed
to size.

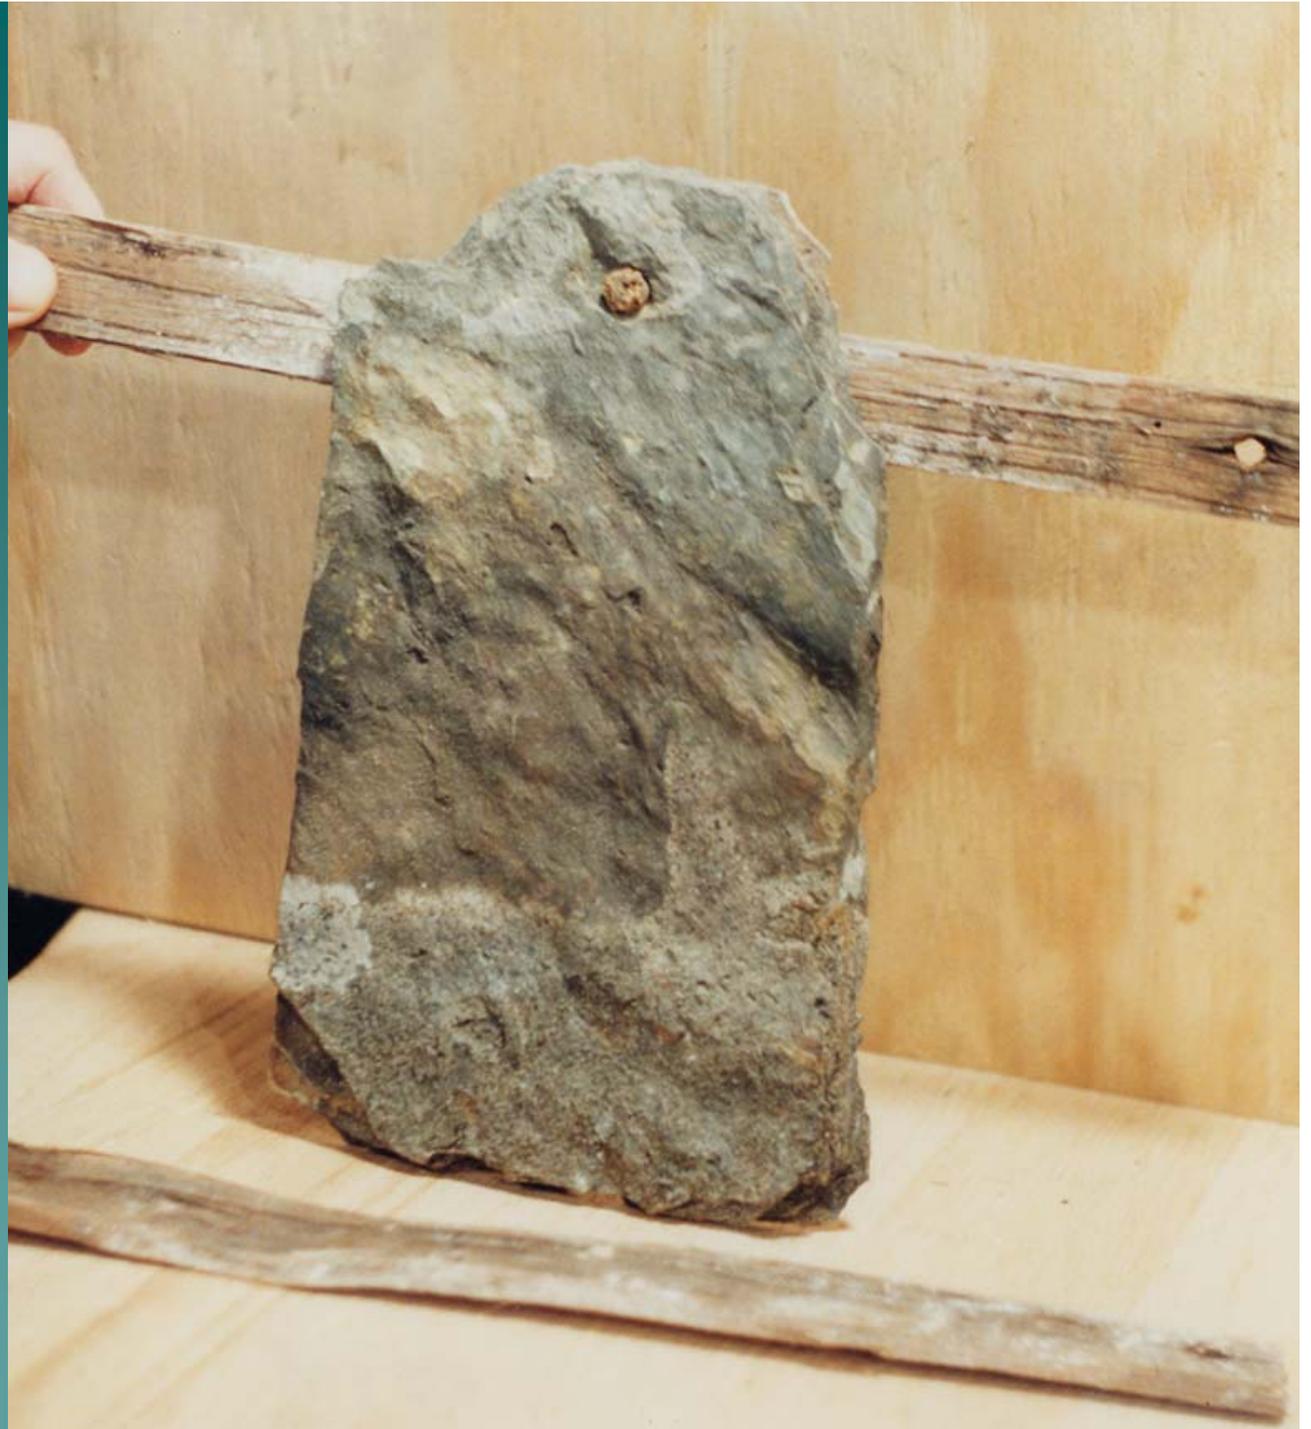
In Europe,
slate roofs
were
originally
hung with
wooden
pegs on
split lath.

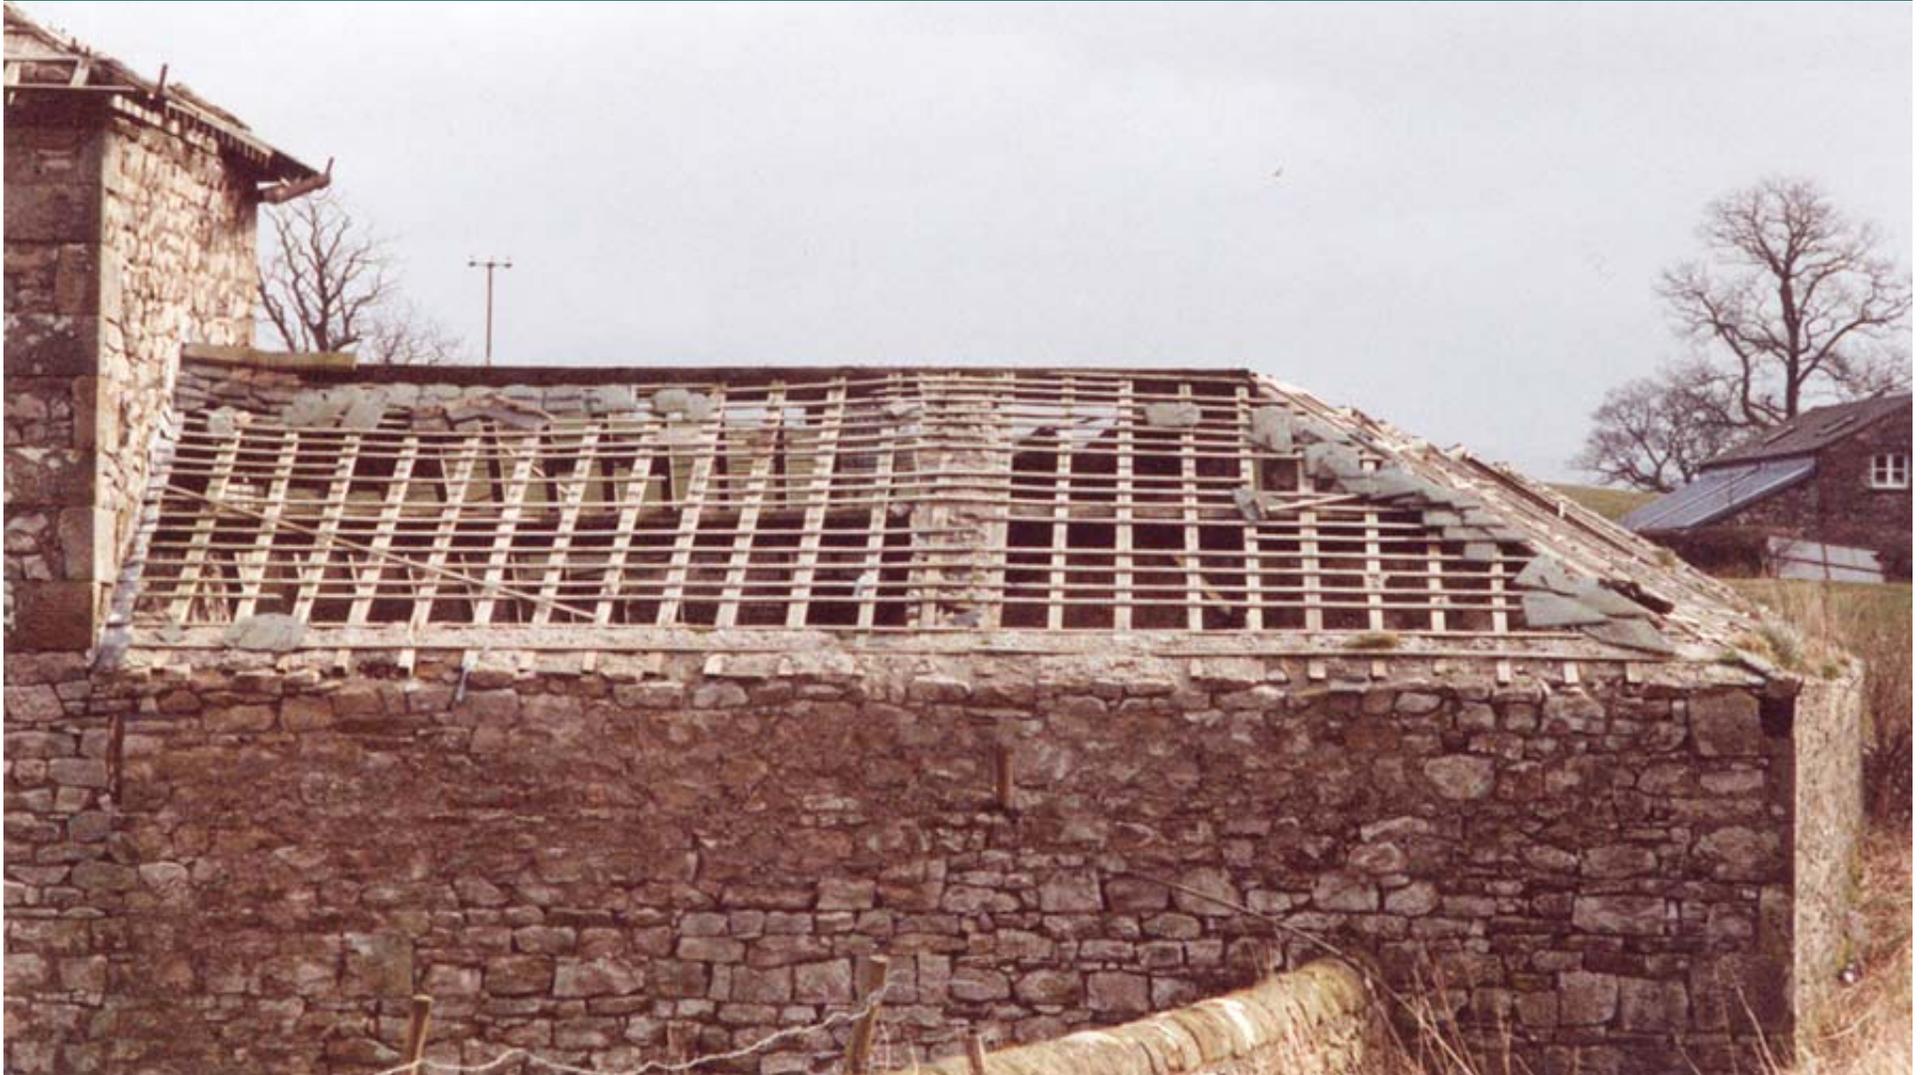
This is a very old UK pegged slate roof
(or what's left of it)

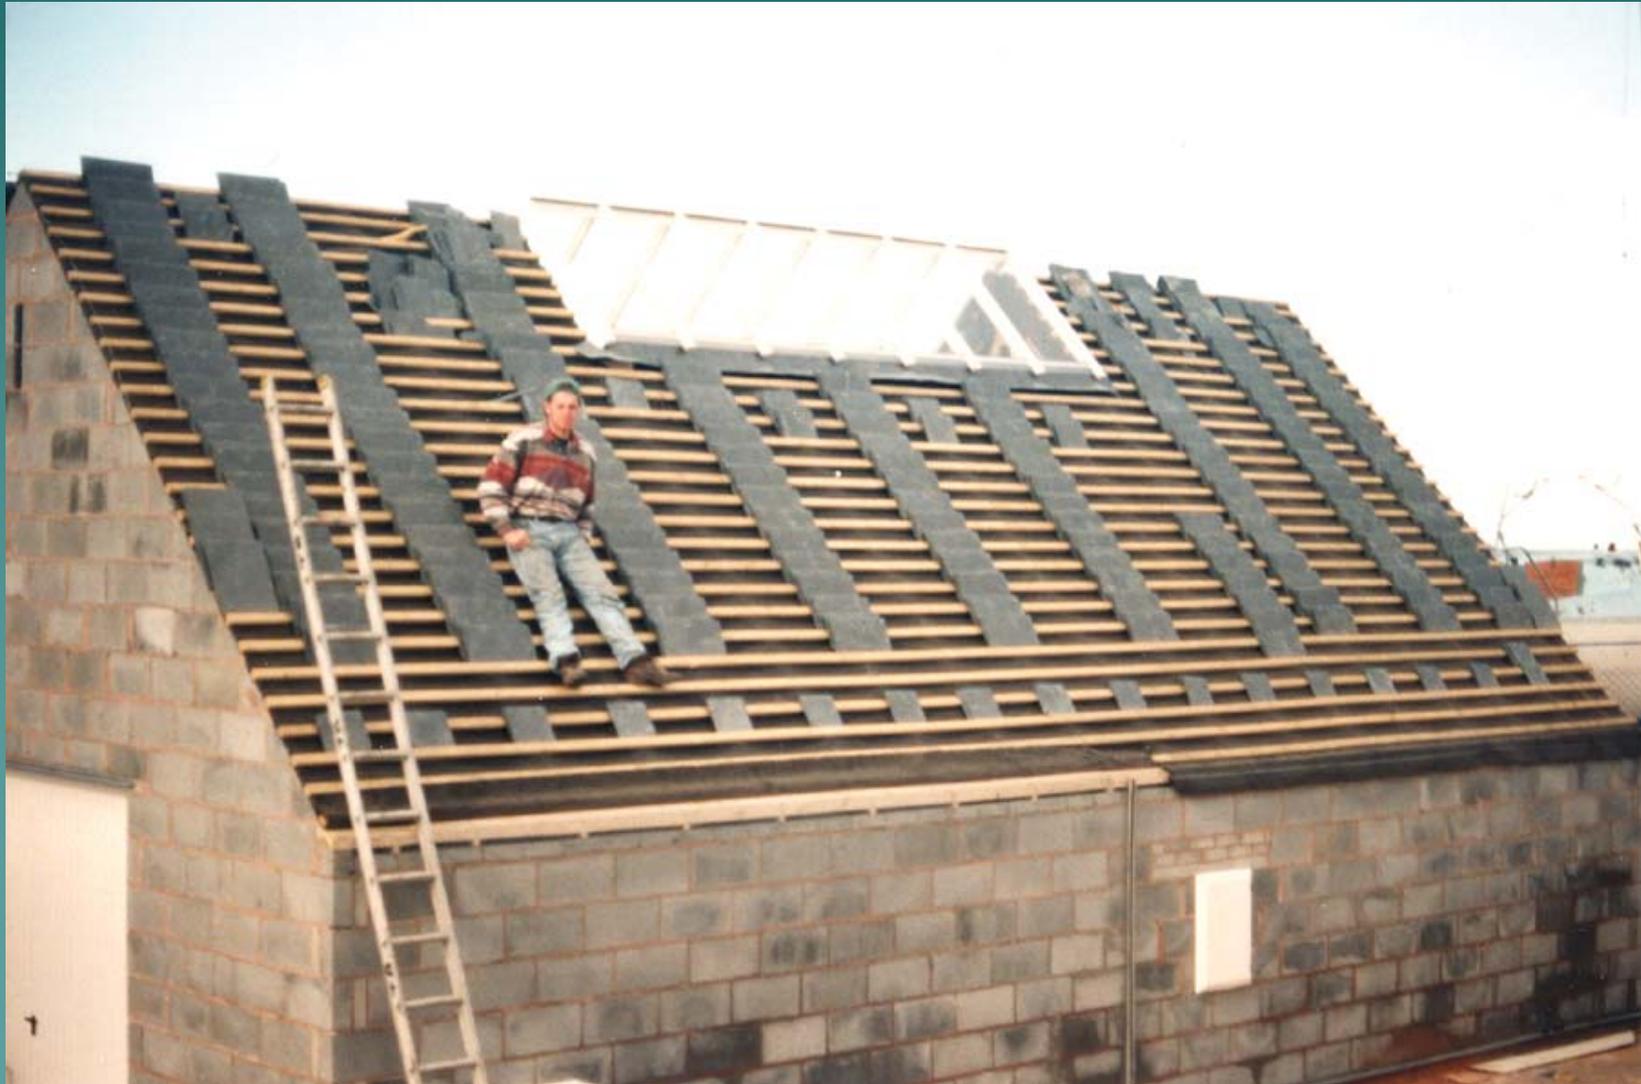
Slate are still installed on “battens” on many European roofs.

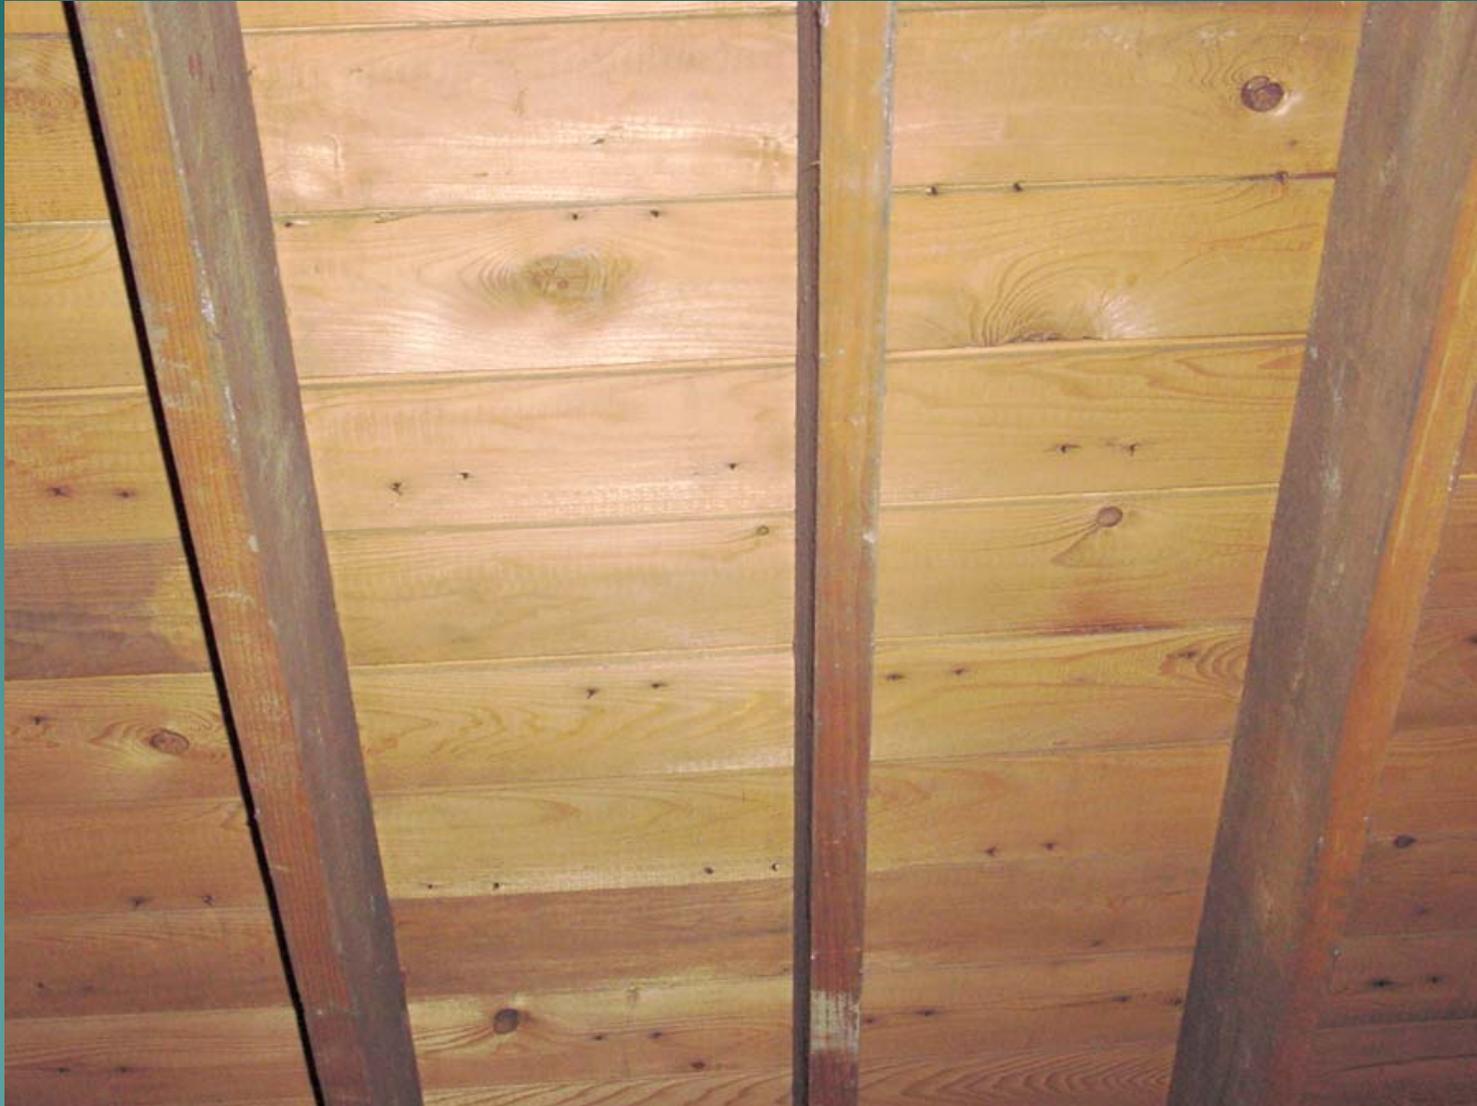
USA: solid board roof decks under slate are patterned after the Scottish system.

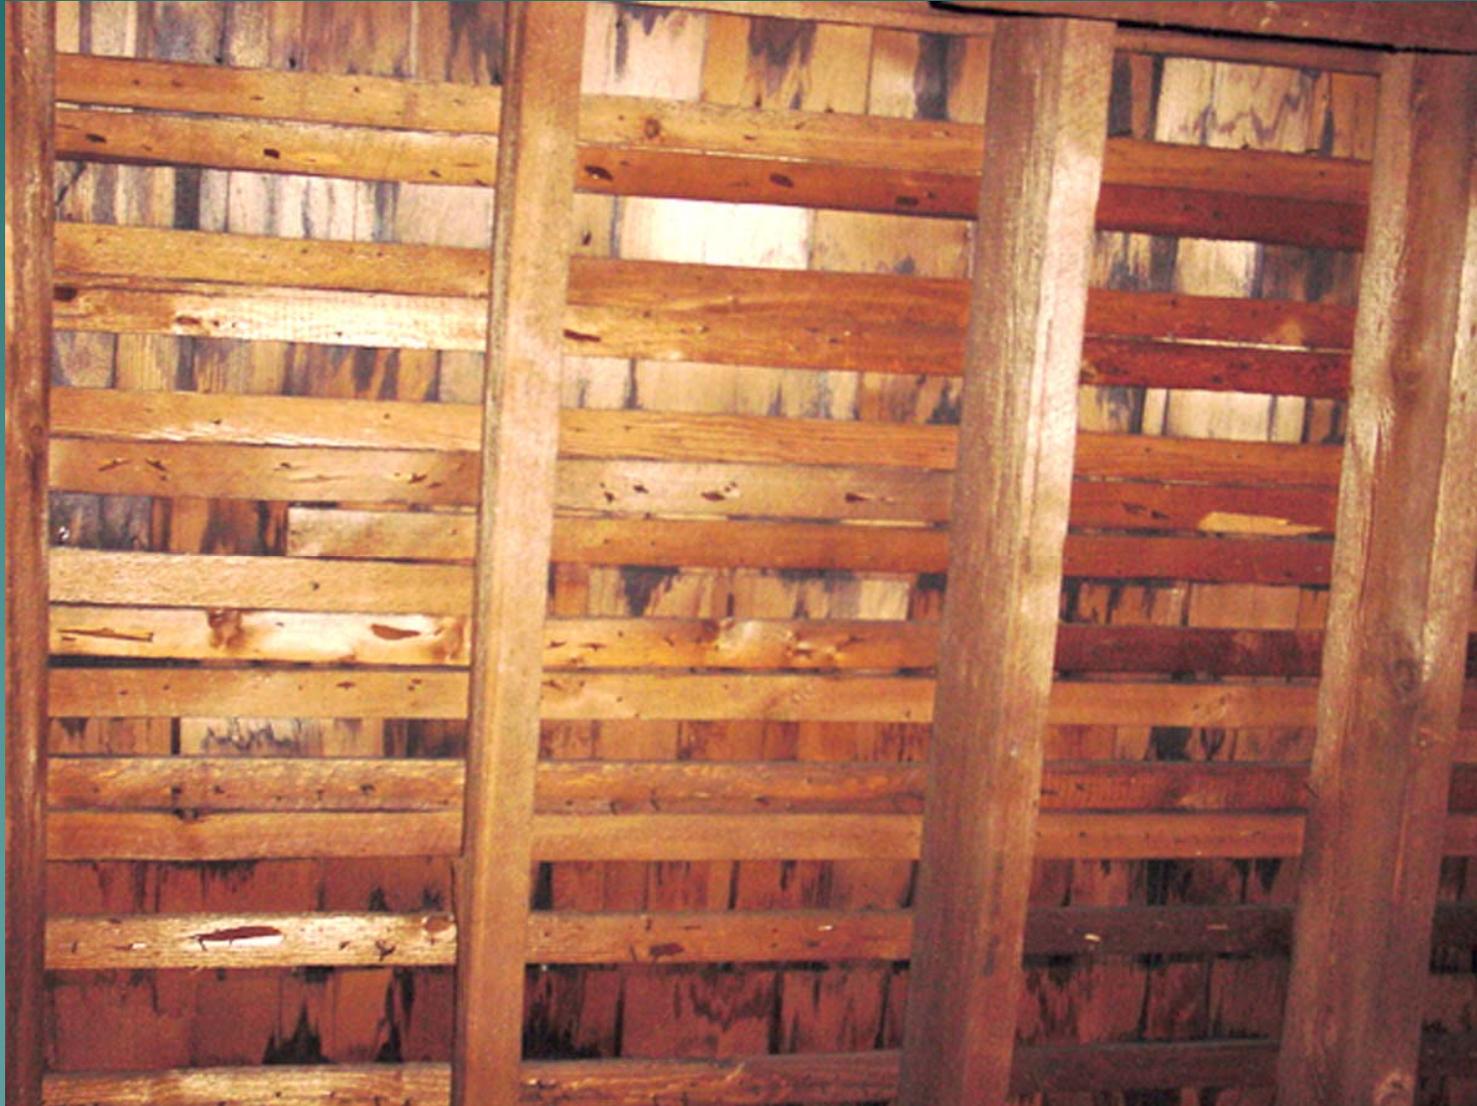
It's not uncommon to find lath with wood shakes under slate.

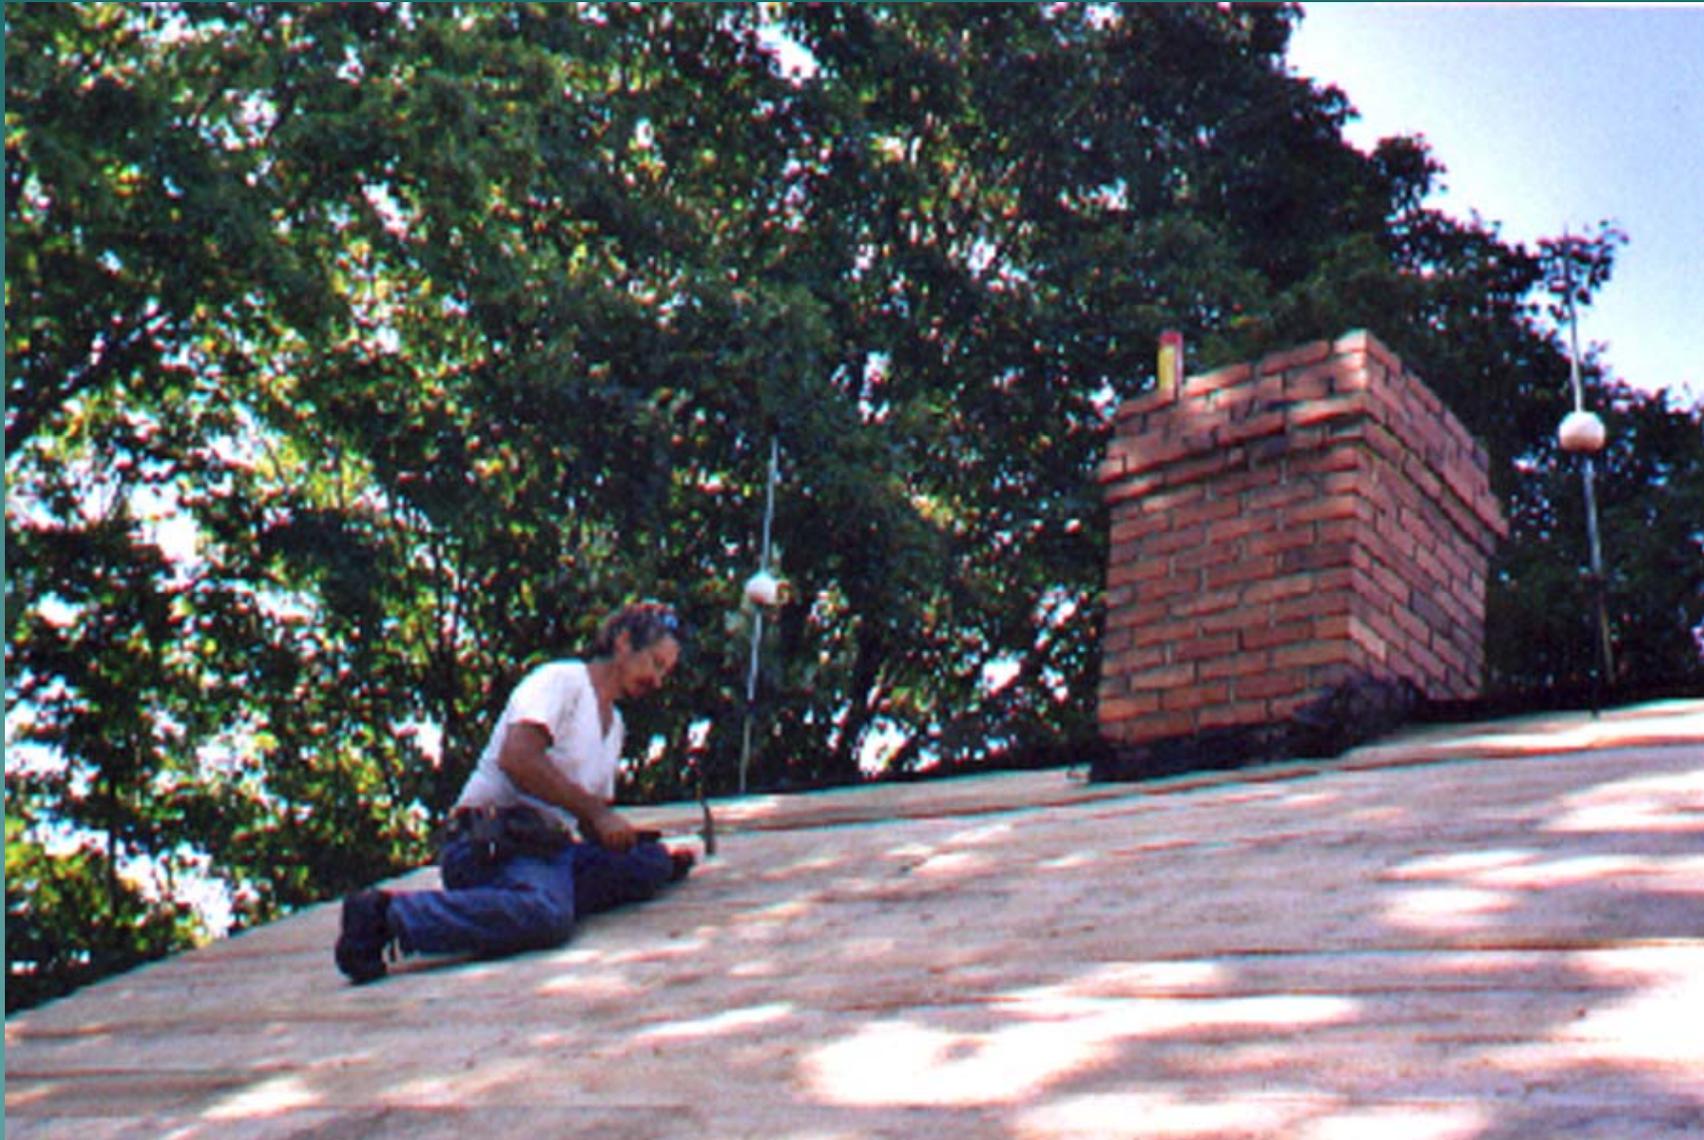
Solid board roof decks provide the best system for slate roofs.

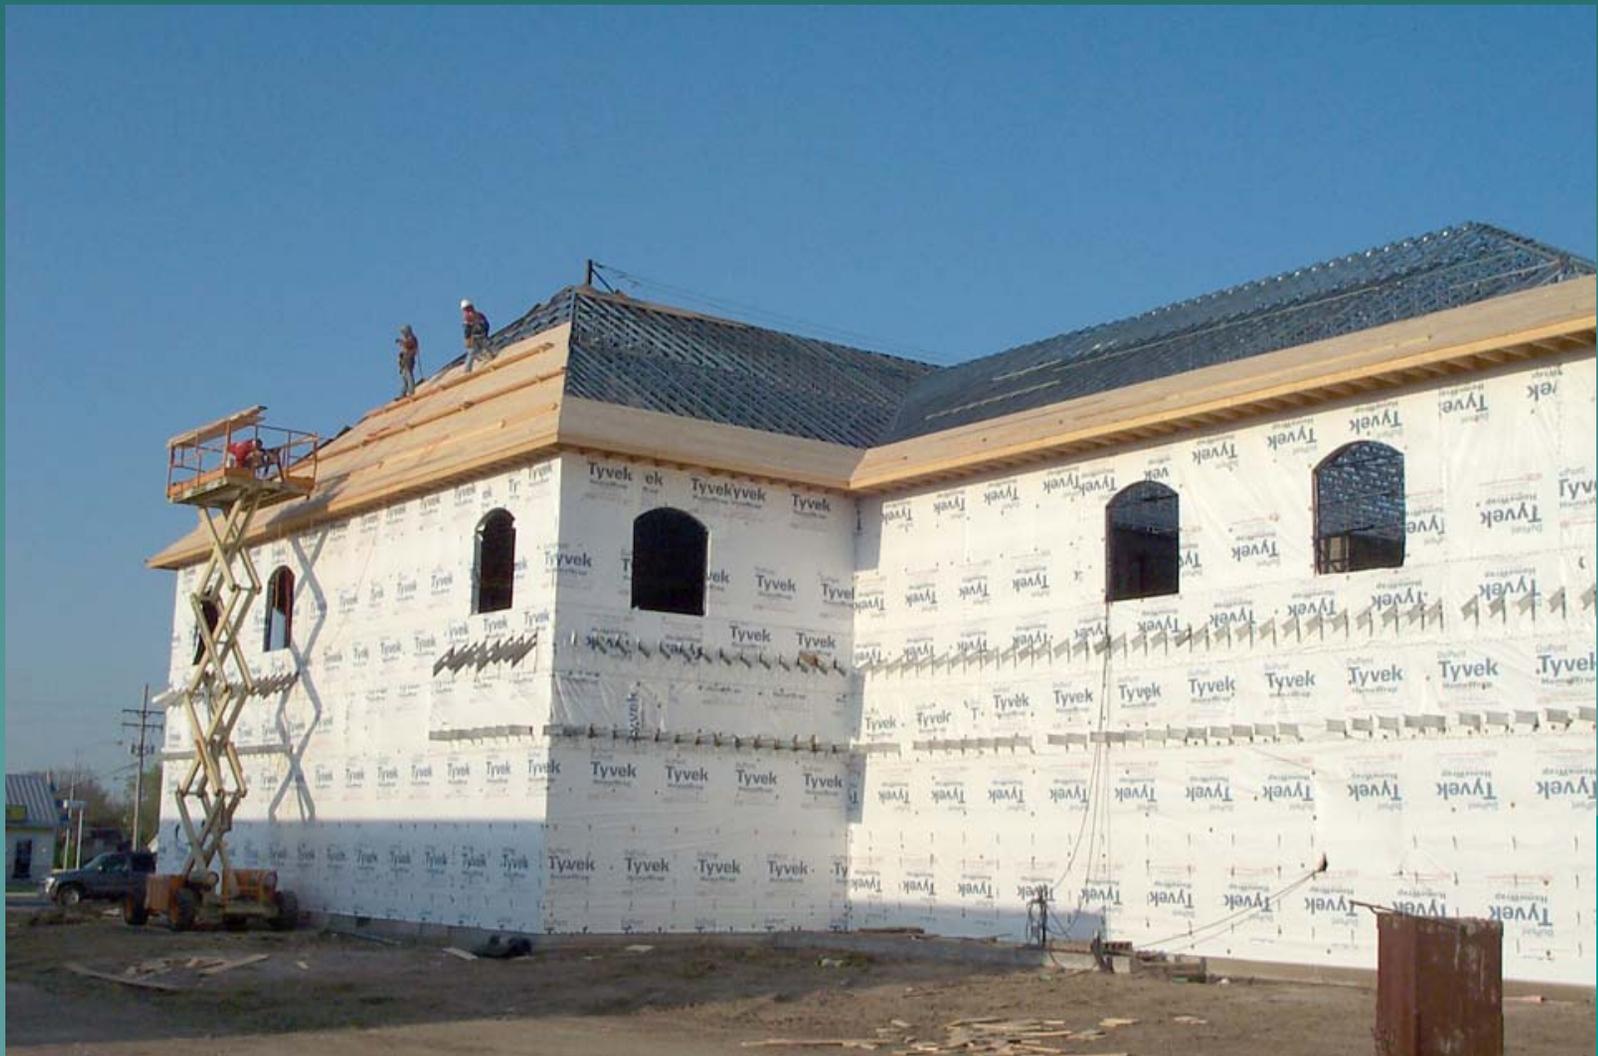
New bank building in Kansas, with kiln-dried yellow pine roof decking.

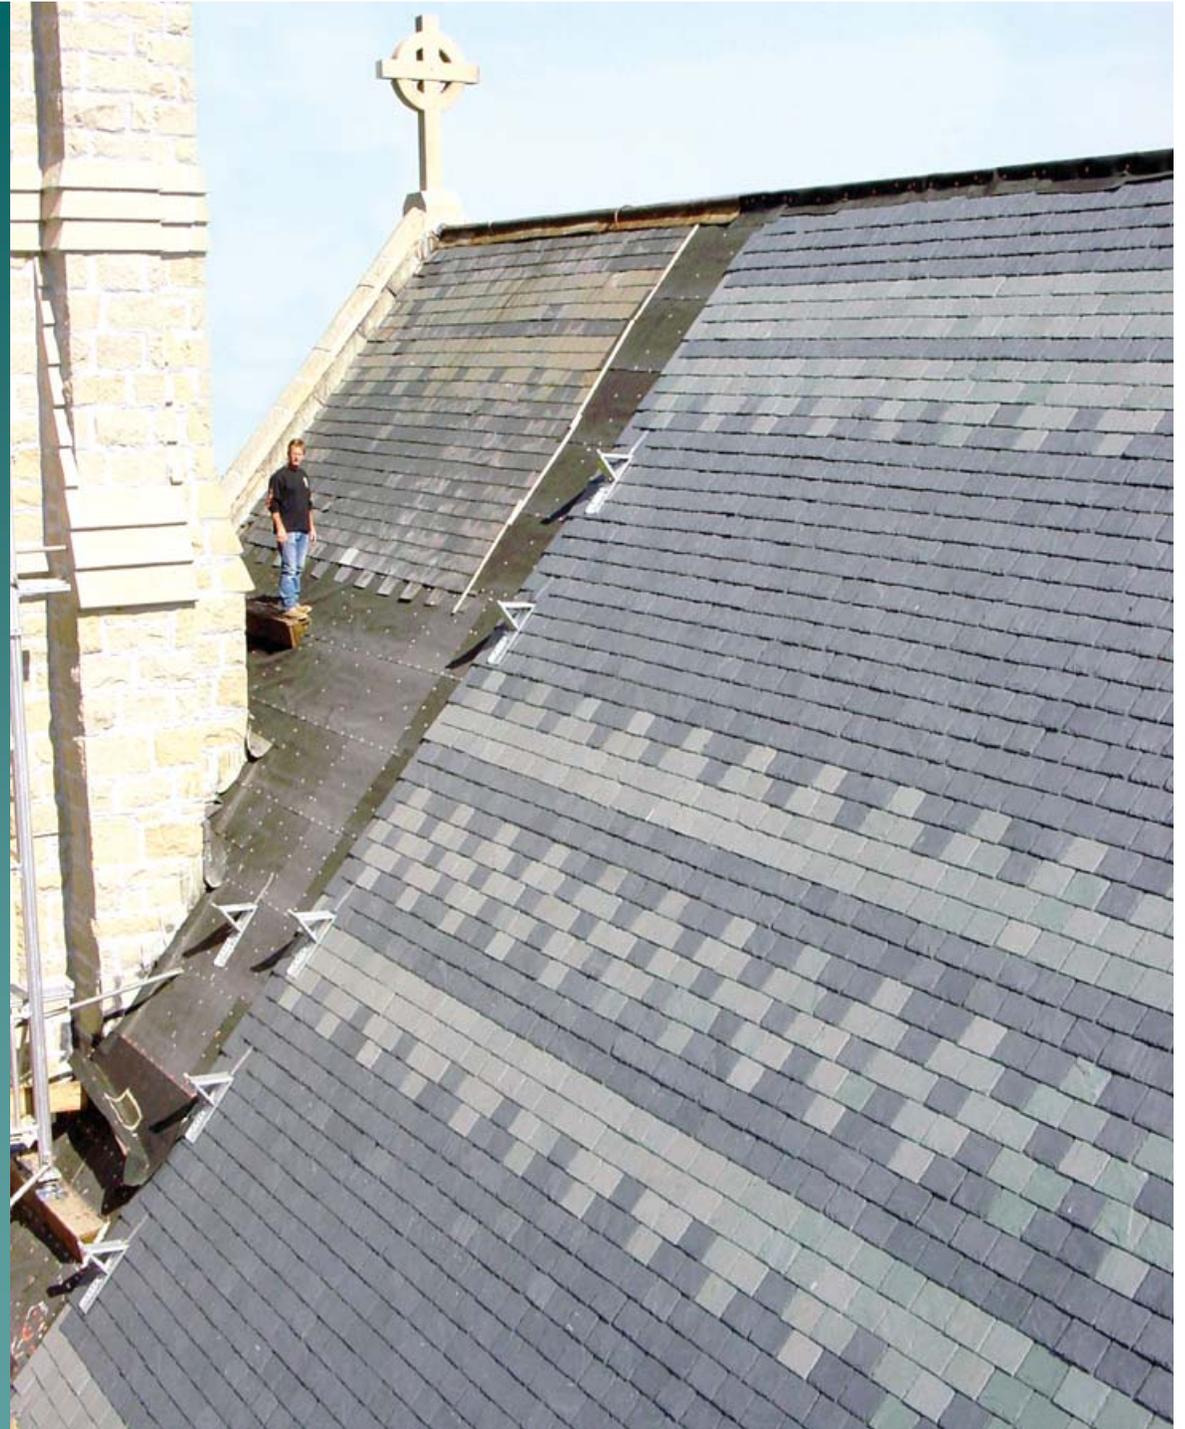
When this 120 year old cathedral roof was reslated, it was found to have no underlayment under the original slates.

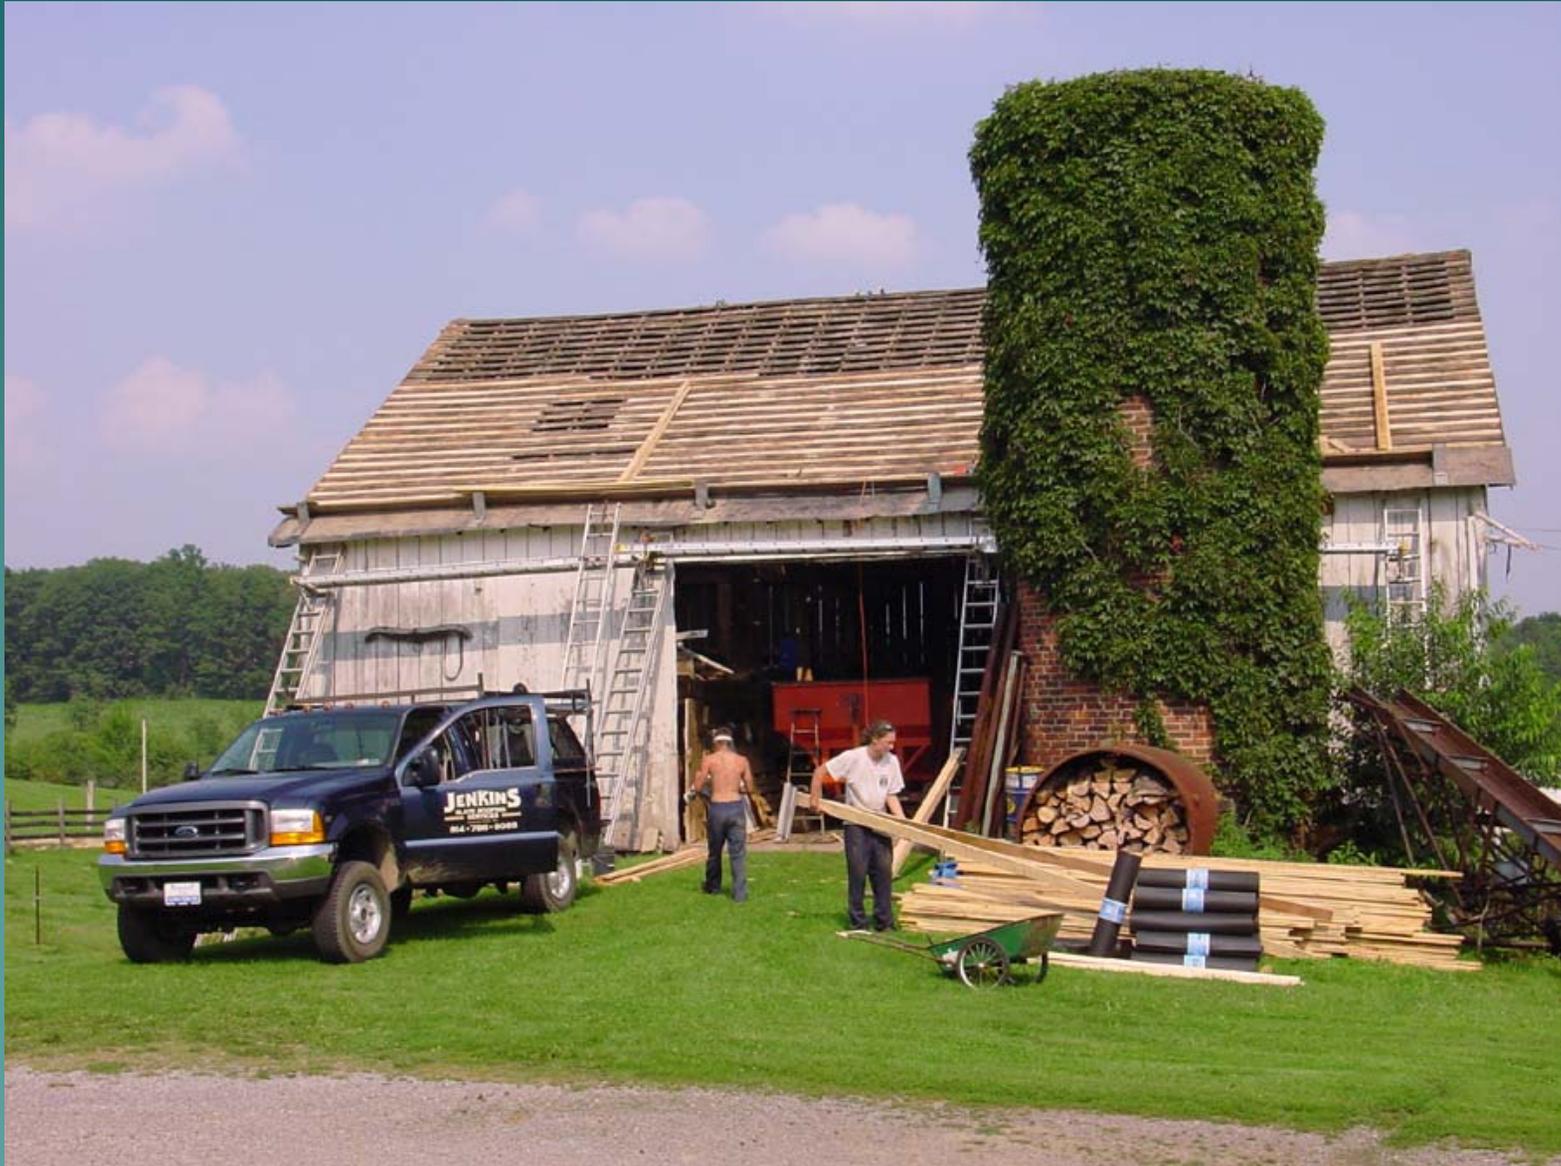
A lath barn being reslated by adding 1x4s between the lath.

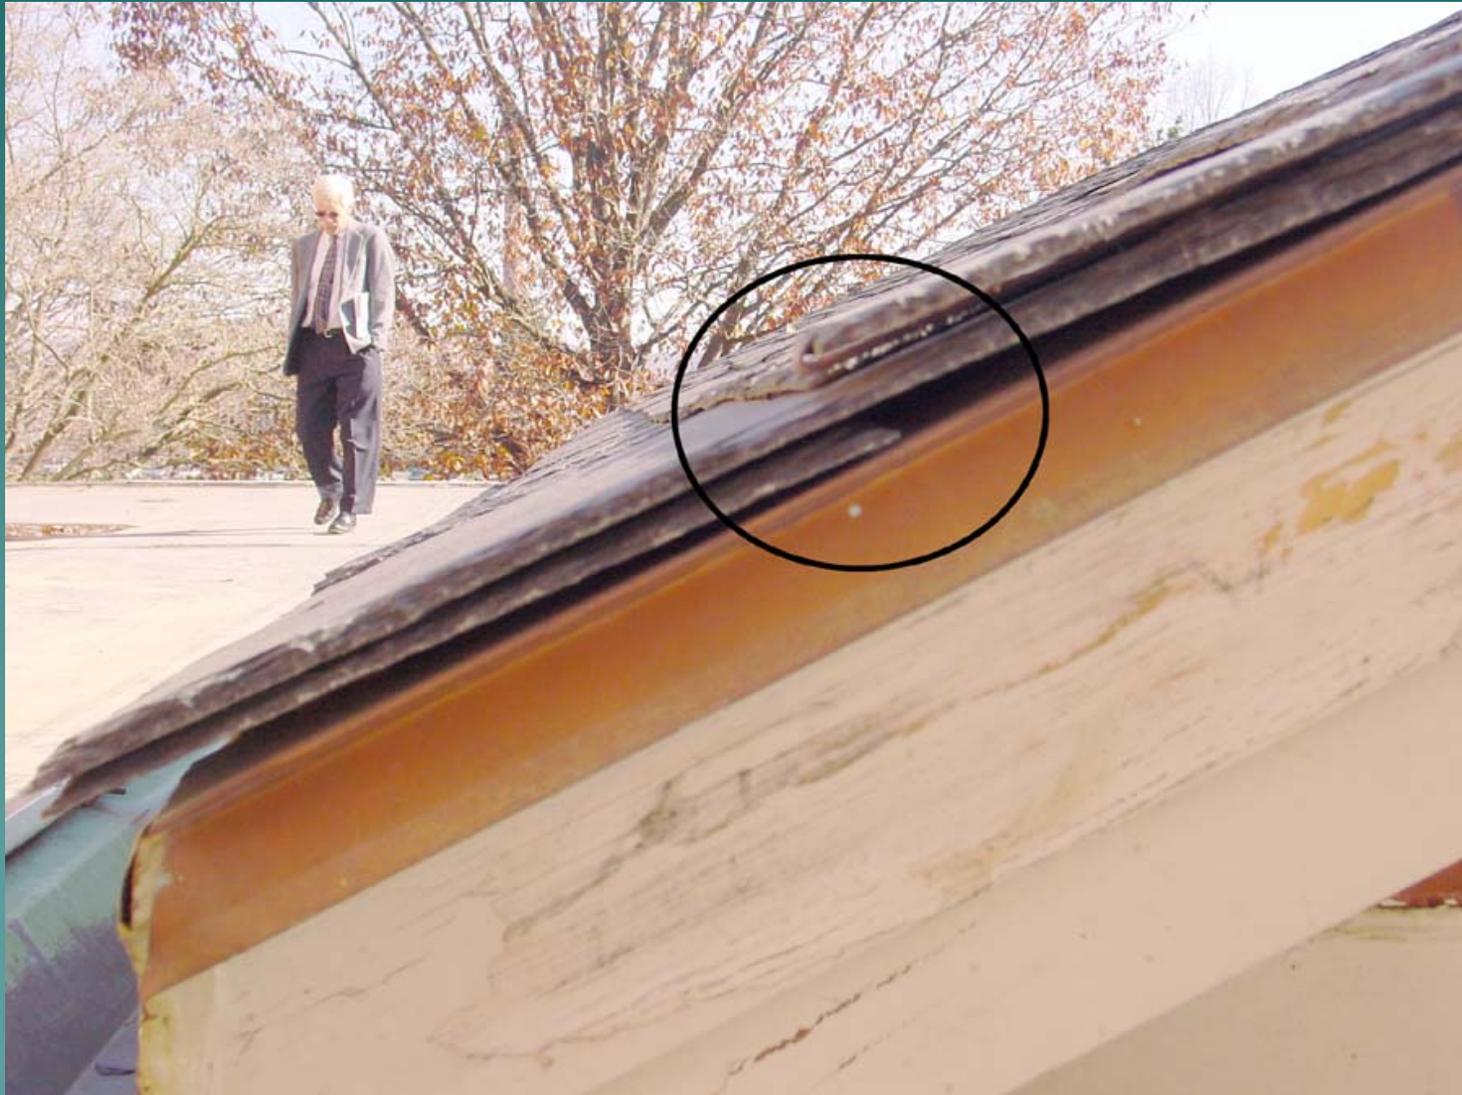
Proper HEADLAP is critical. This new slate roof at a university was installed incorrectly.
