Traditional American Slate Roofs

Their Anatomy, Maintenance and
Repair

By Joe Jenkins

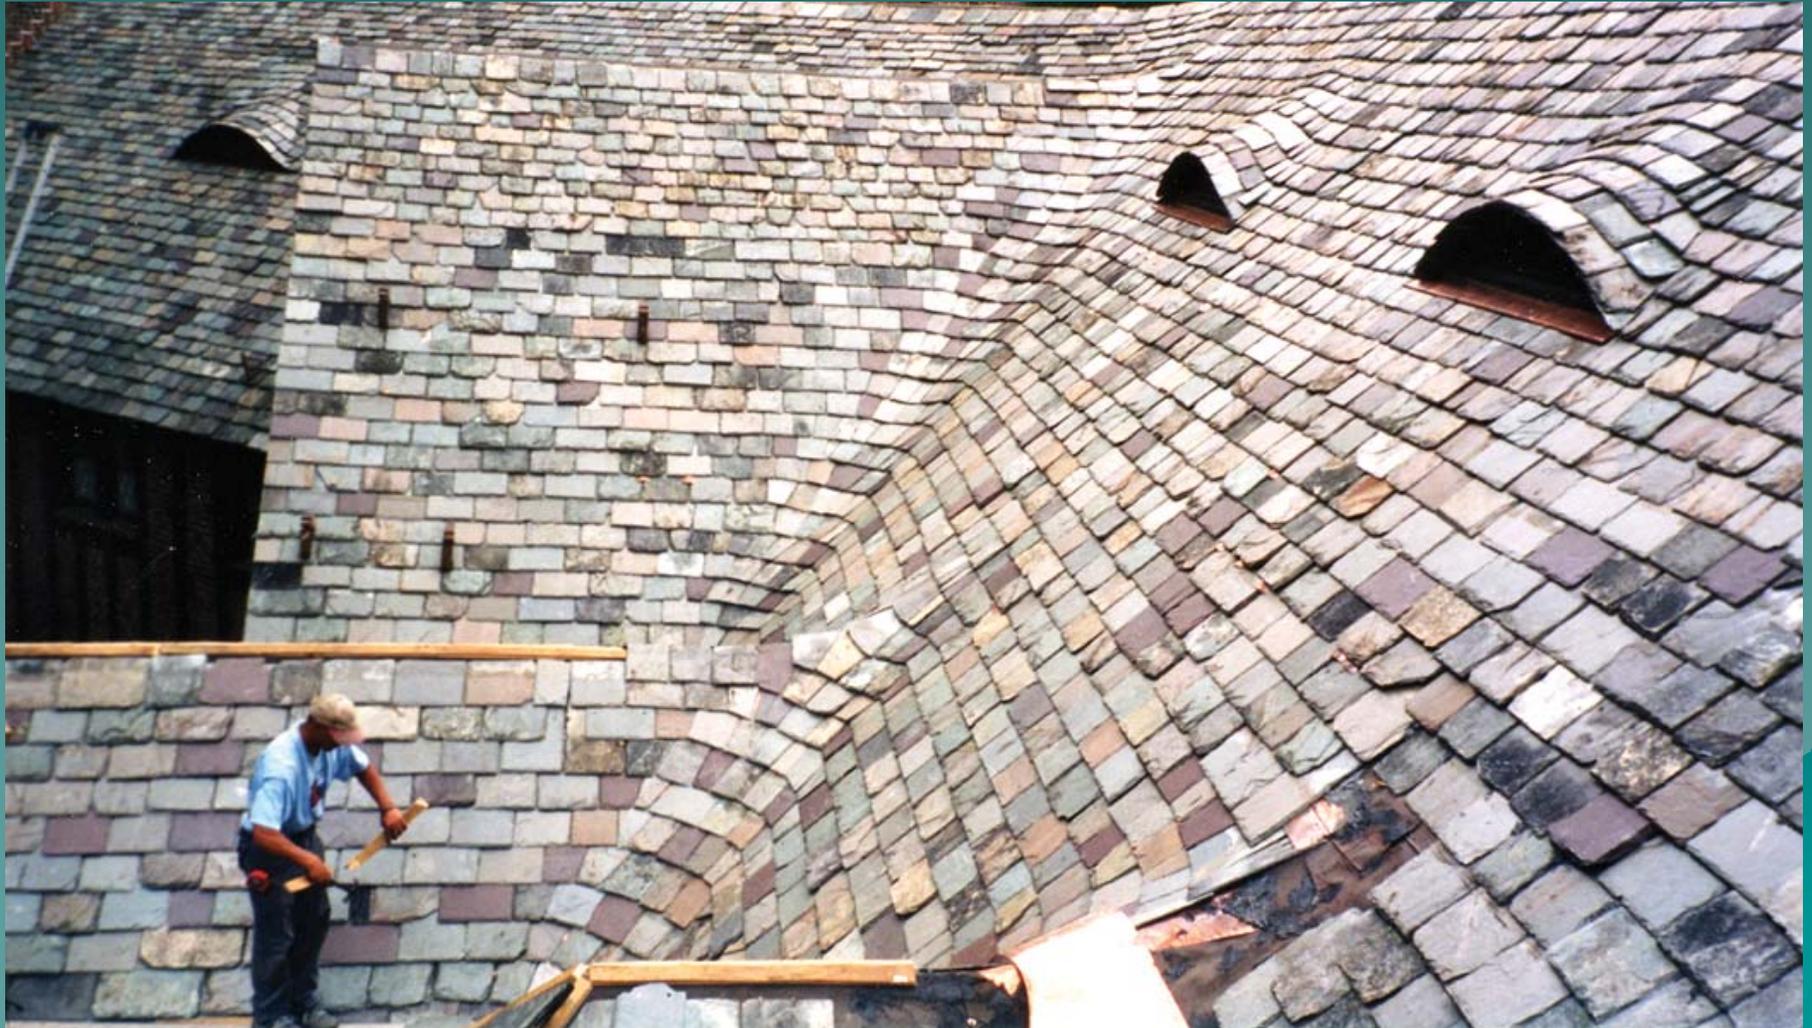
The entire graduated slate roof had to be removed and reslated.

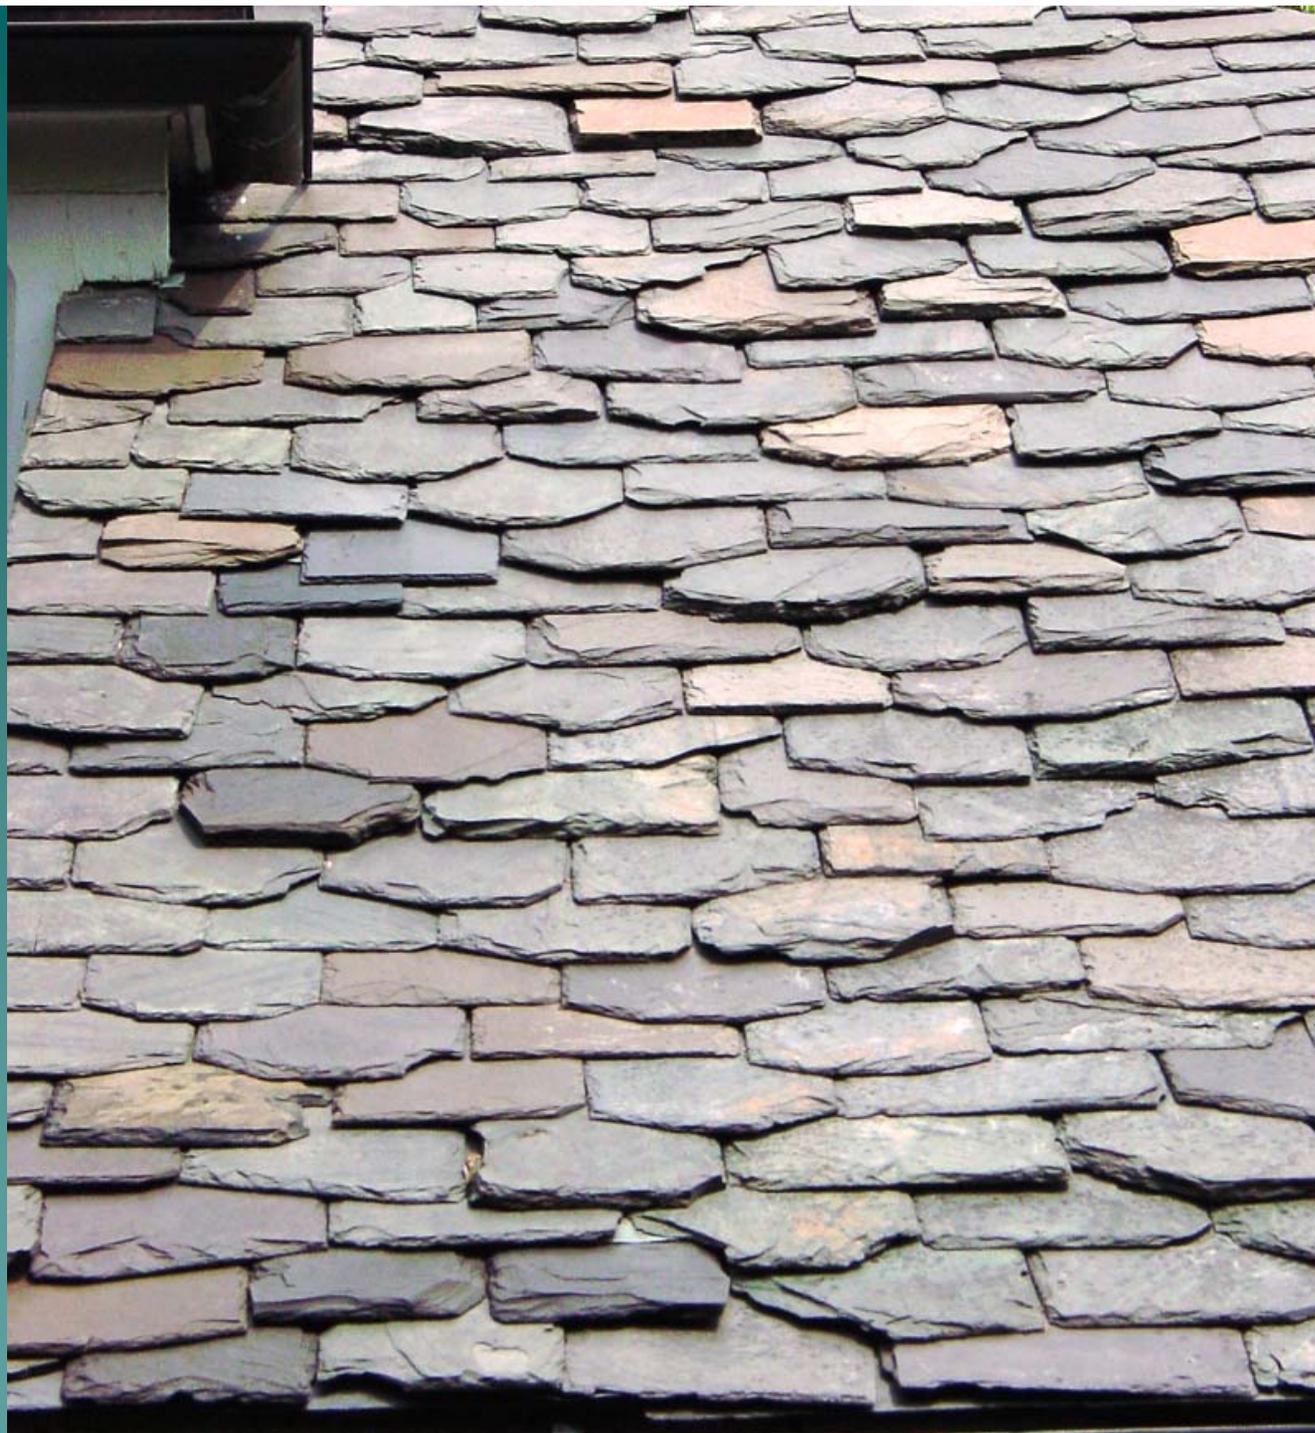
Slate is versatile and can be installed in many styles. This is a “ragged butt” style.

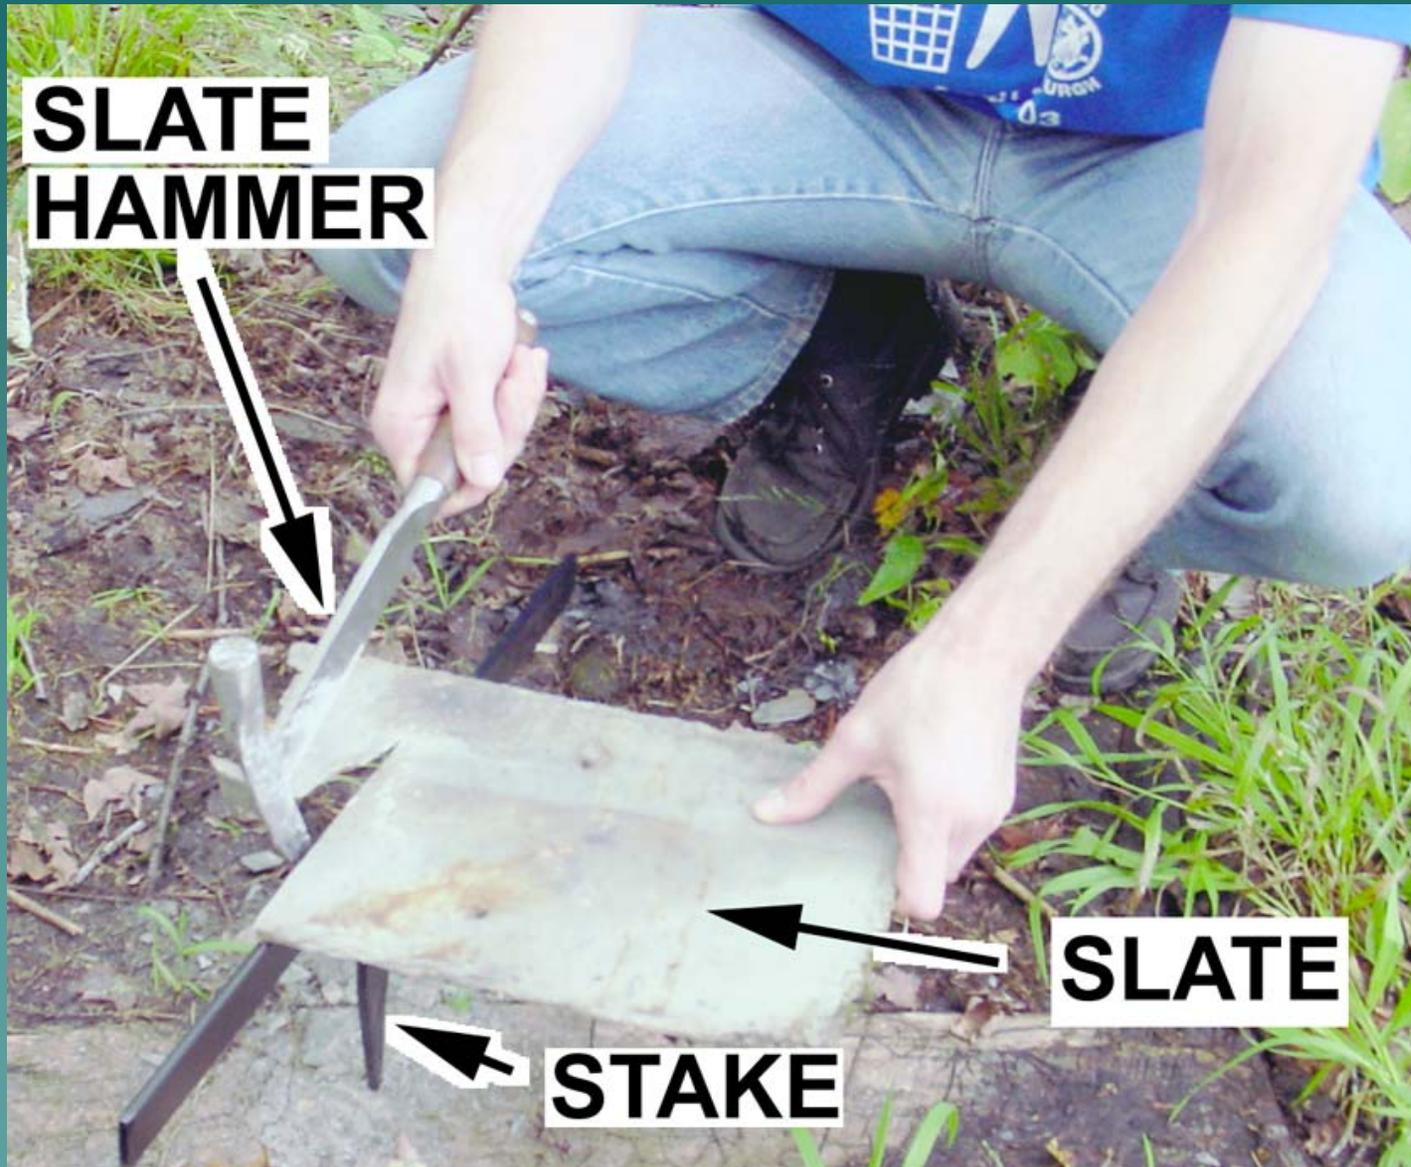
Slates can be cut with a hammer and a stake.

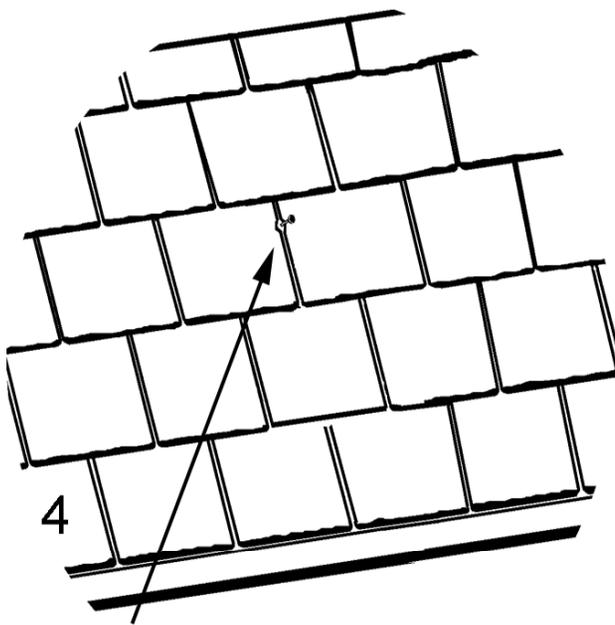
The nail and bib repair is common and acceptable. Exposed strap hangers are not acceptable.

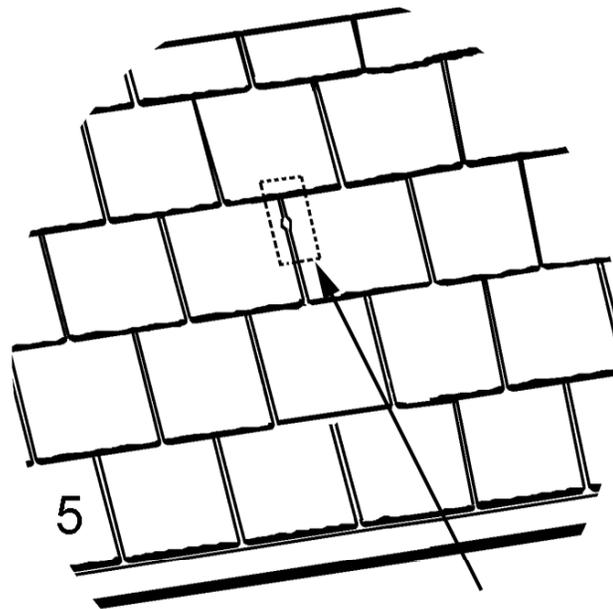
Replacement slate is slid into place and fastened with a nail in the slot

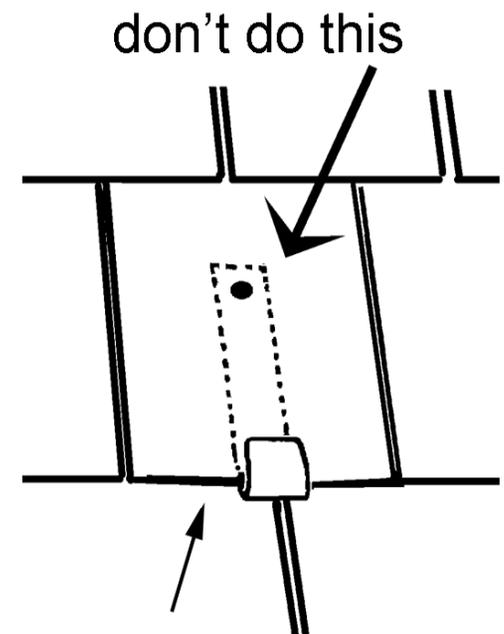
The roofing nail is tapped down and a bib flashing is slid under the slate but over the nail head

The above strap technique is undesirable for two basic reasons: it looks bad and the straps are easily bent open by sliding ice and snow

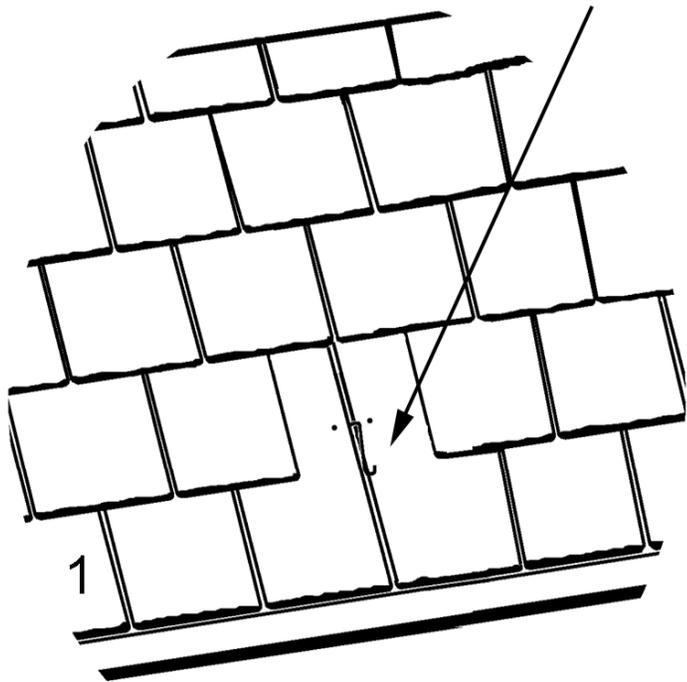
Alternatively, a copper or stainless steel slate hook can be nailed into place after the old broken slate has been removed

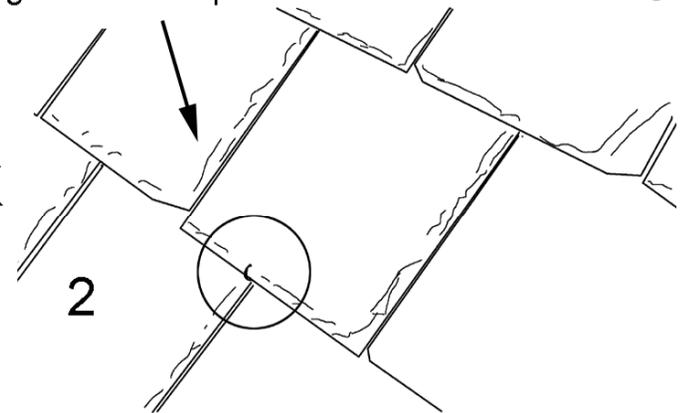
SLATE HOOK REPAIR

The replacement slate is then slid in place where it is permanently held by the slate hook. The hook can be pushed down between the underlying slates, if needed, in order to make more room for sliding the slate in place.

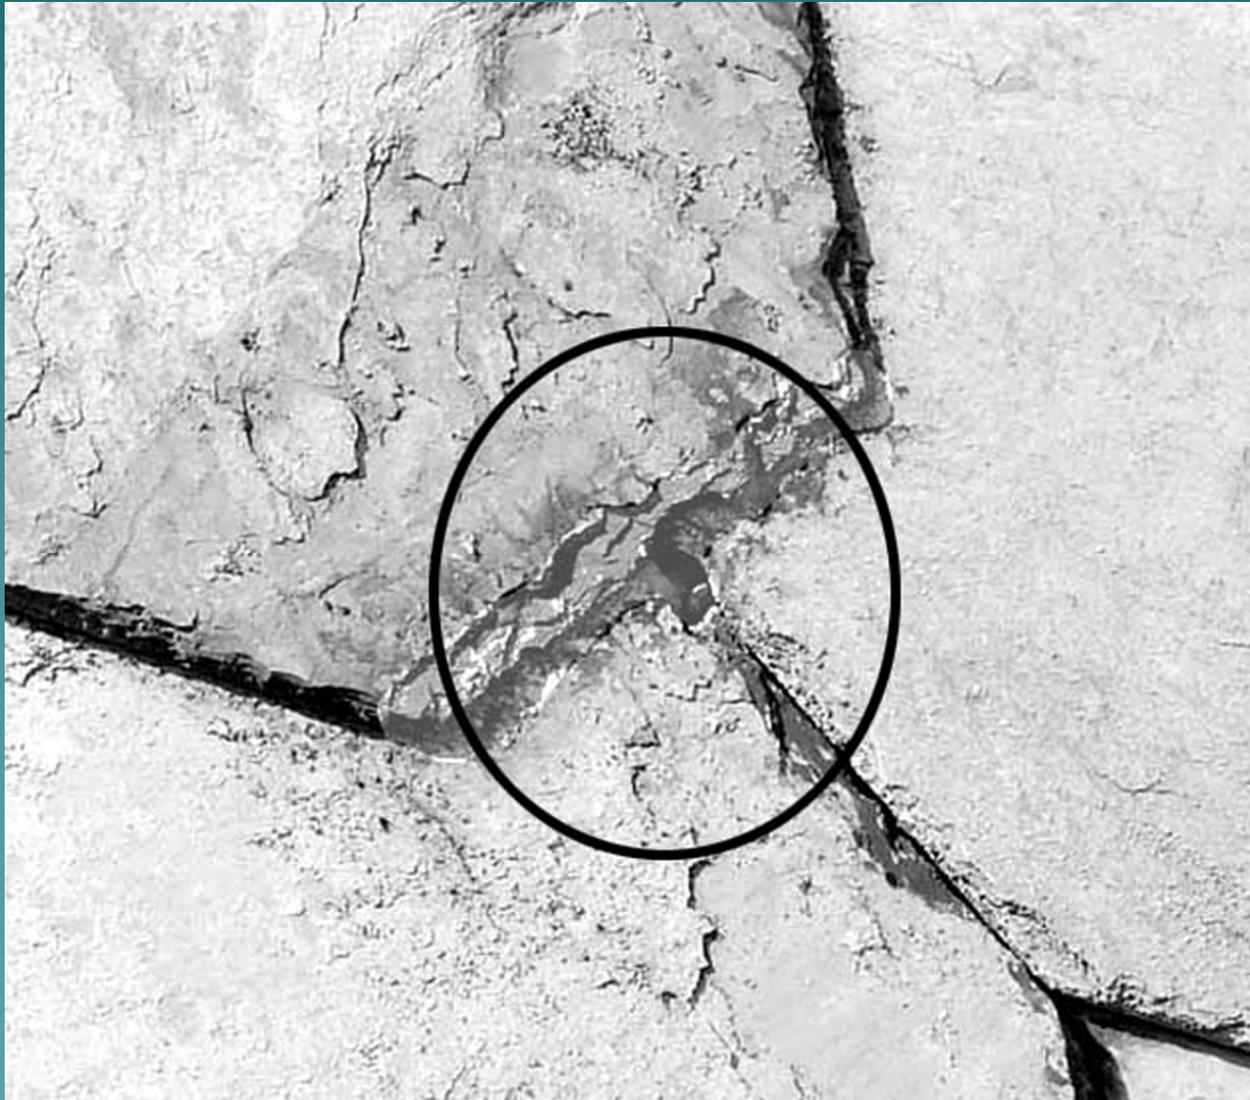
A hidden nail creates a hidden leak.

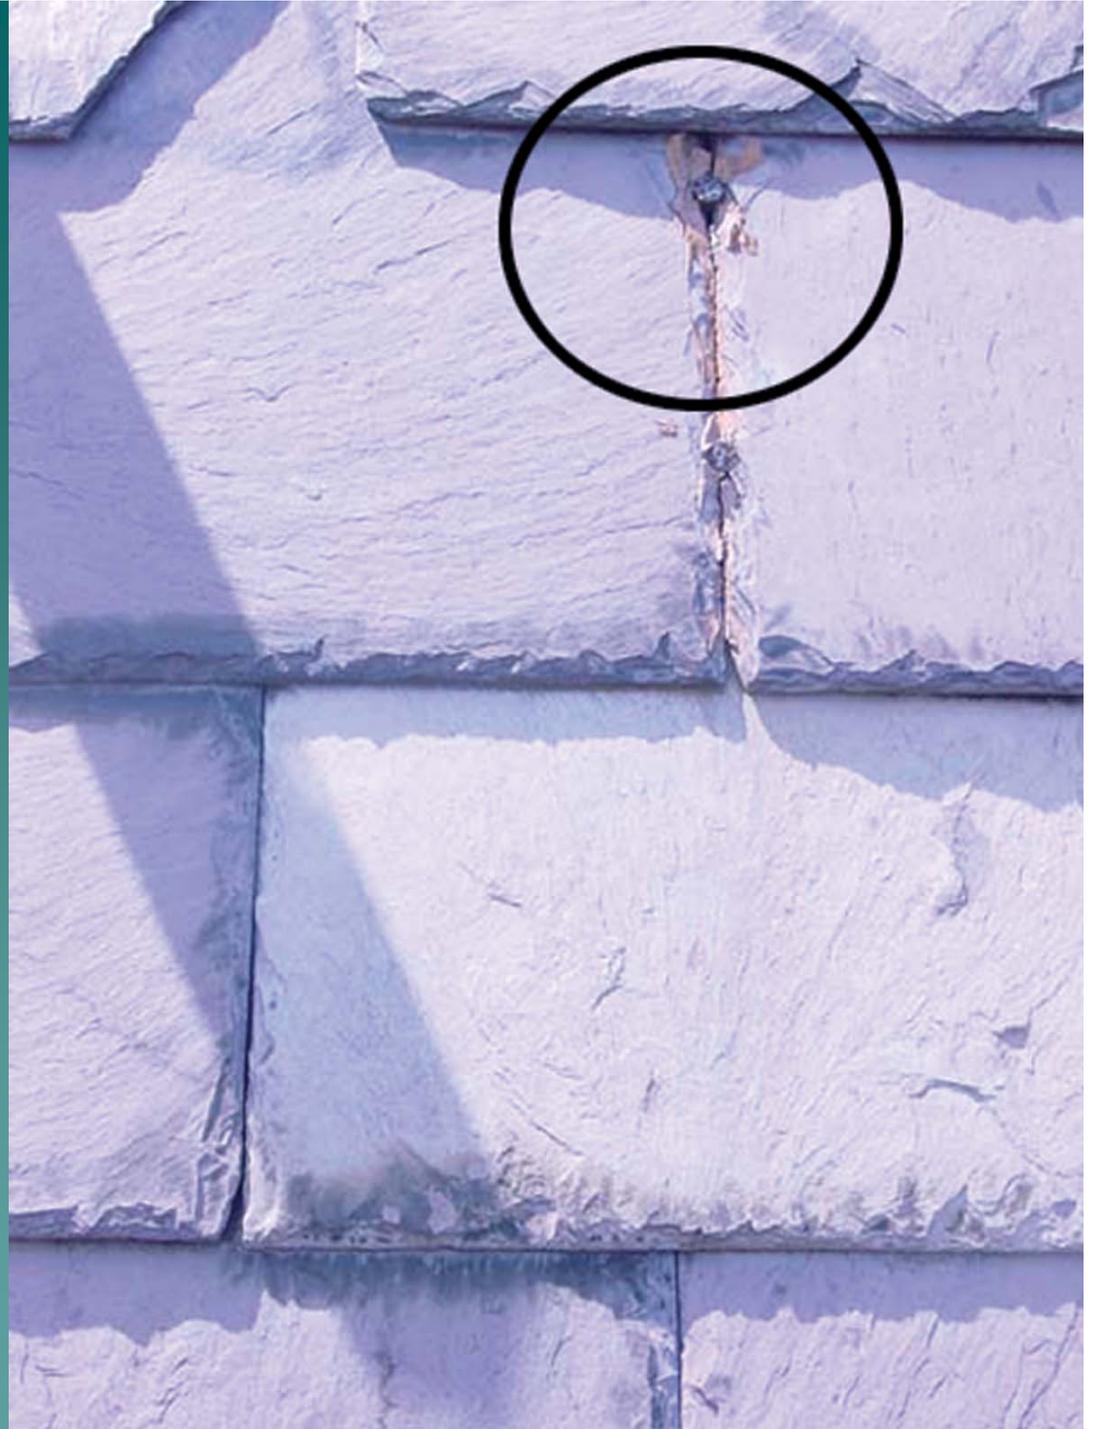
Nail without
a bib flashing
will leak.

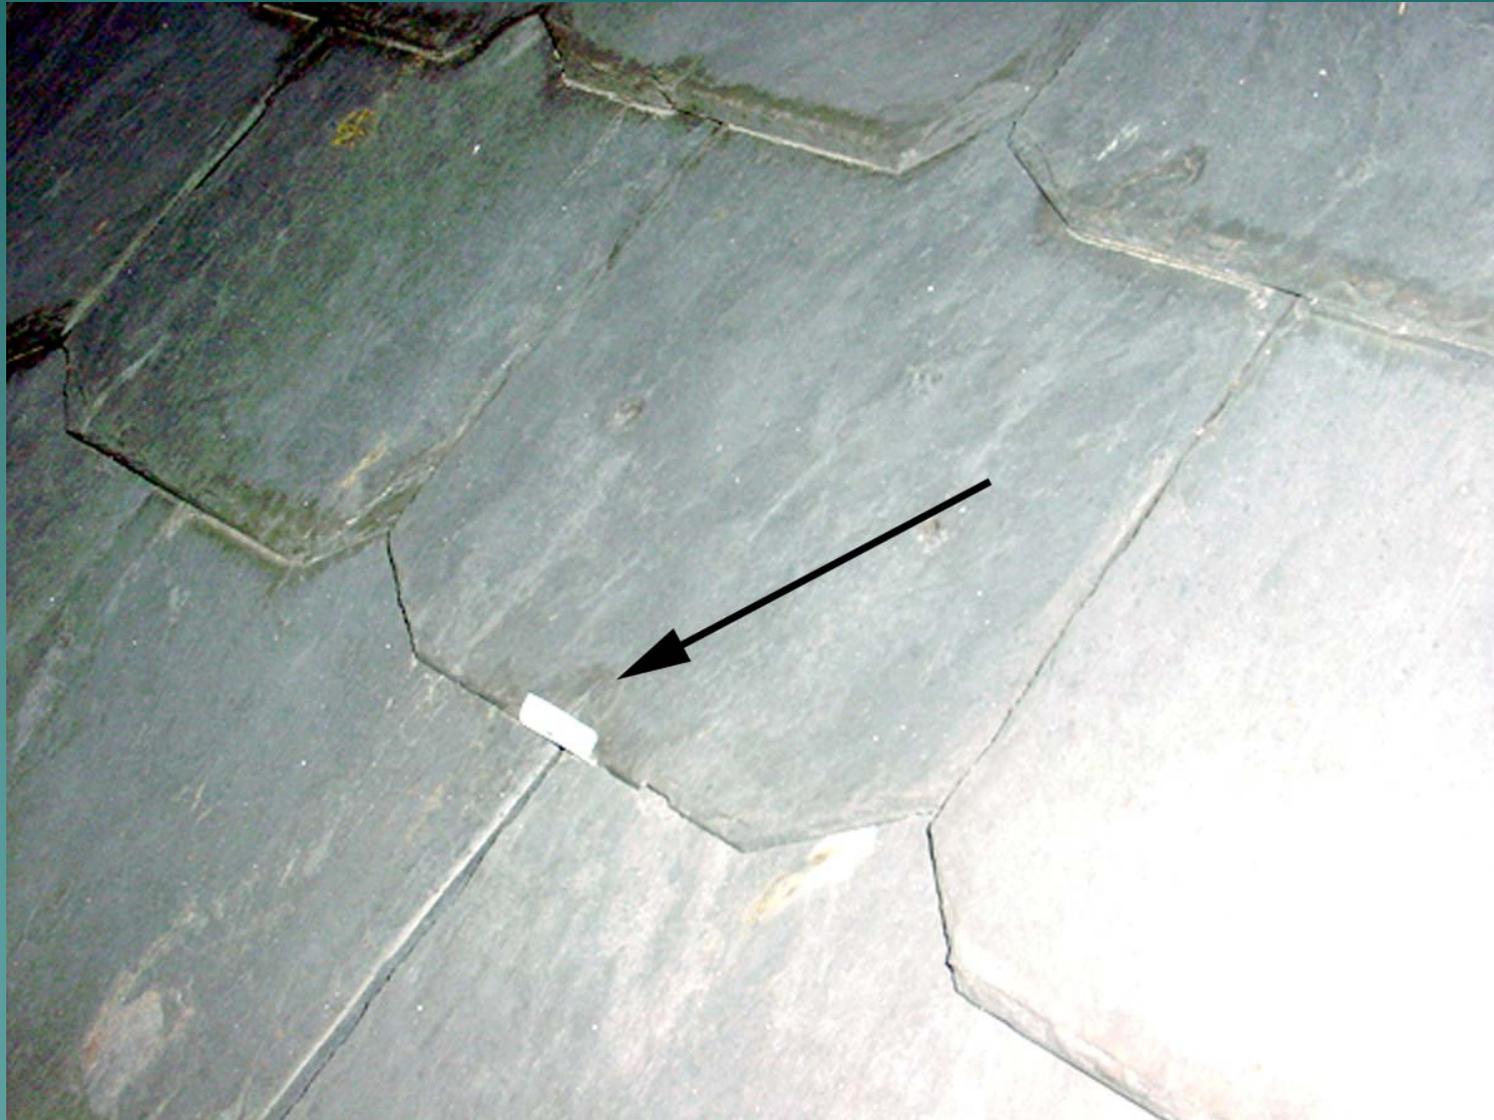
Strap hangers are a mistake.

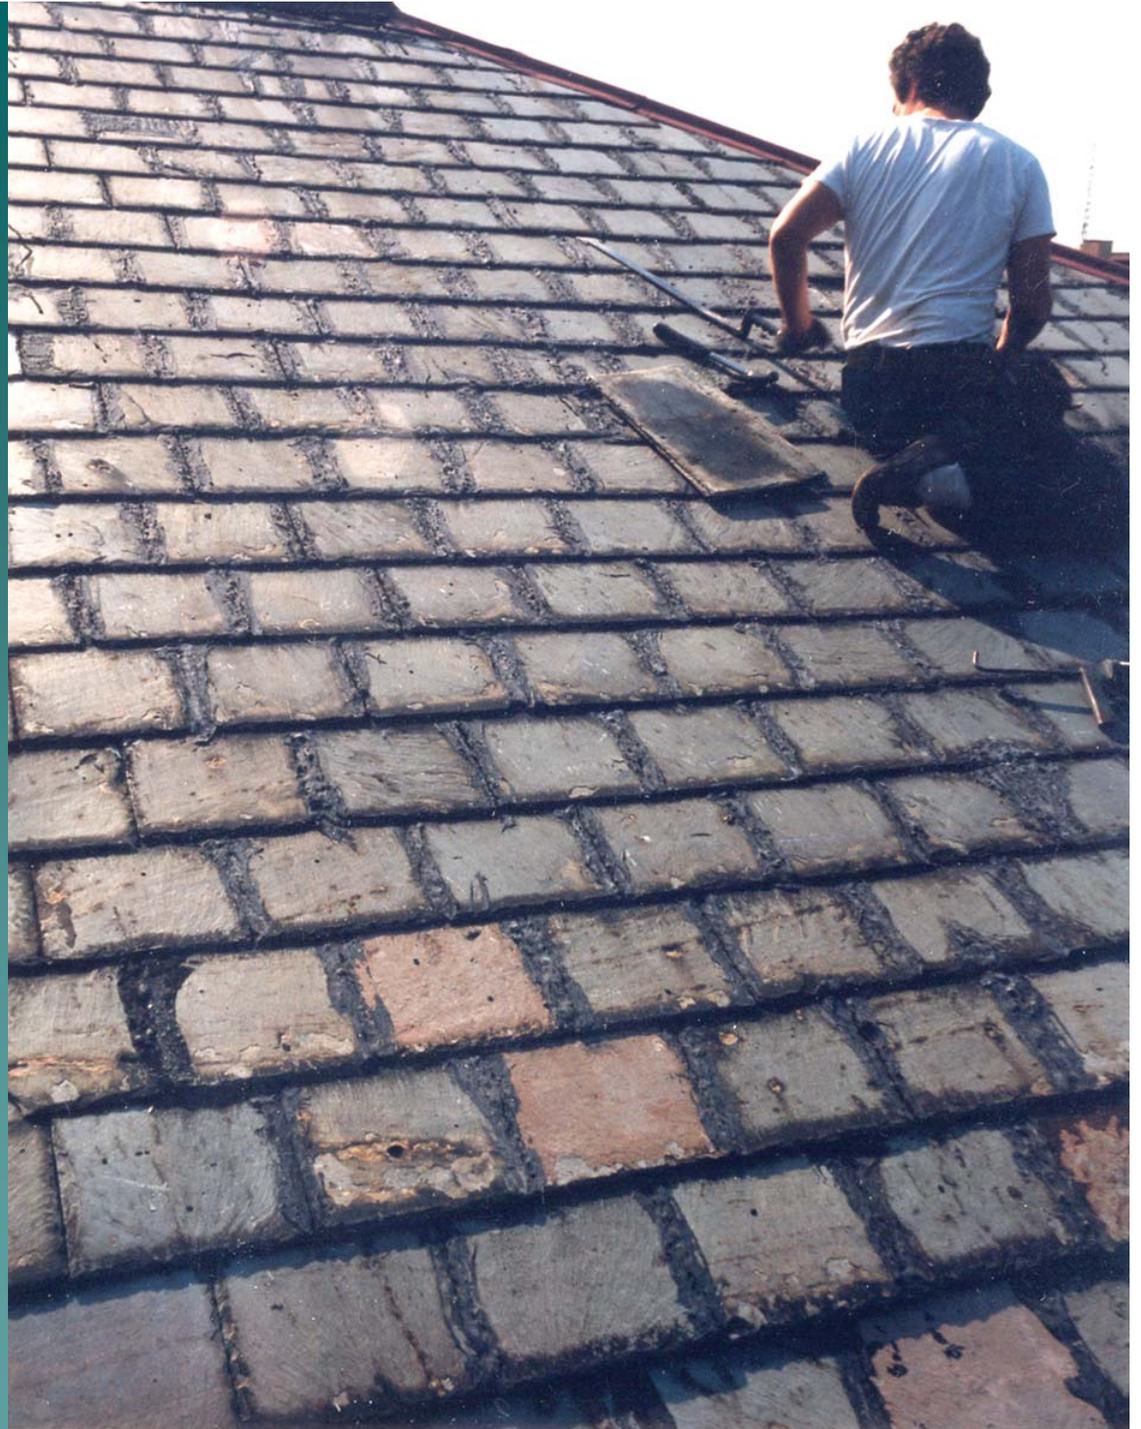
Surface tar
(roof cement
or “mastic”) is
a mistake.

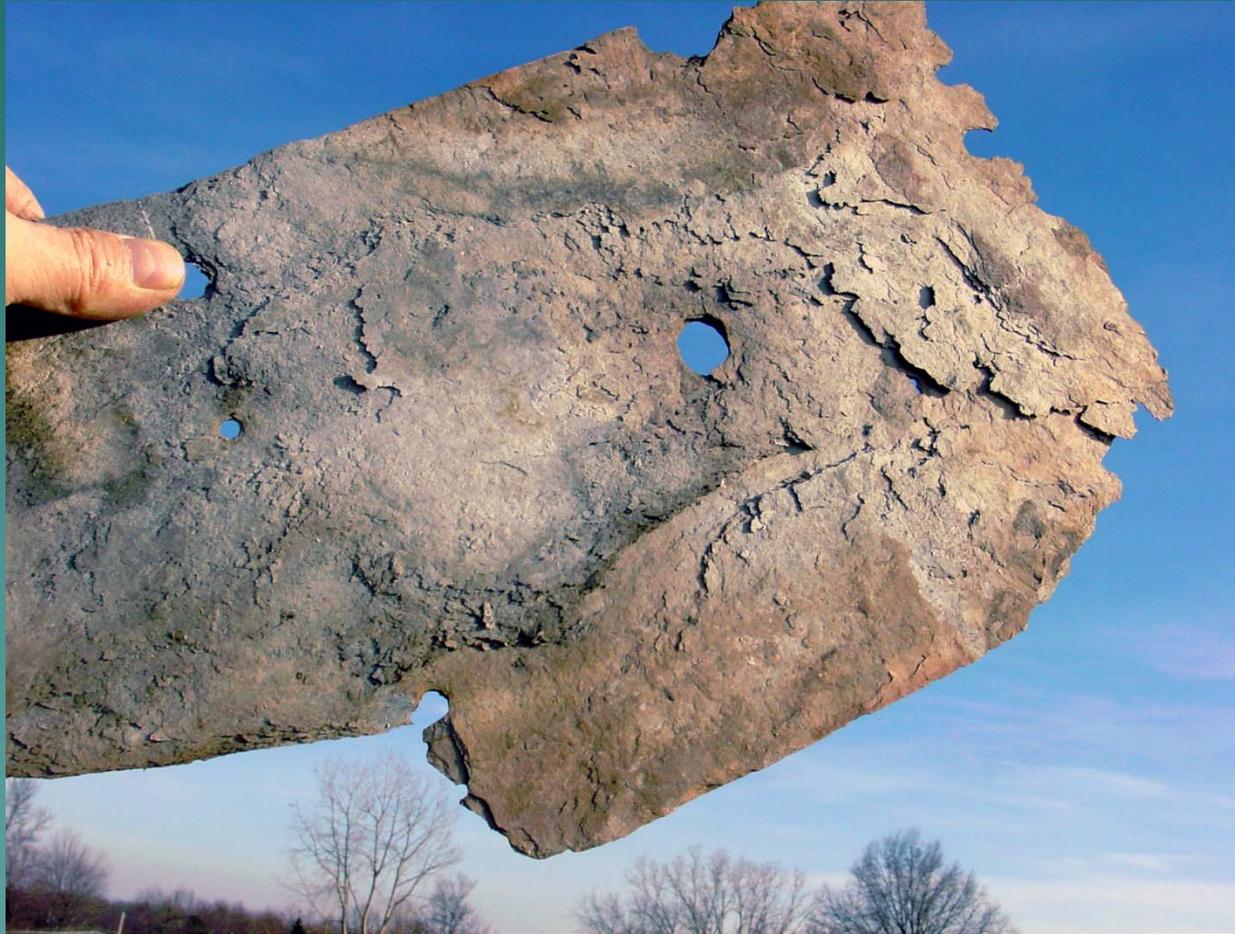
Slates have limited longevities. Those that are worn out cannot be restored.

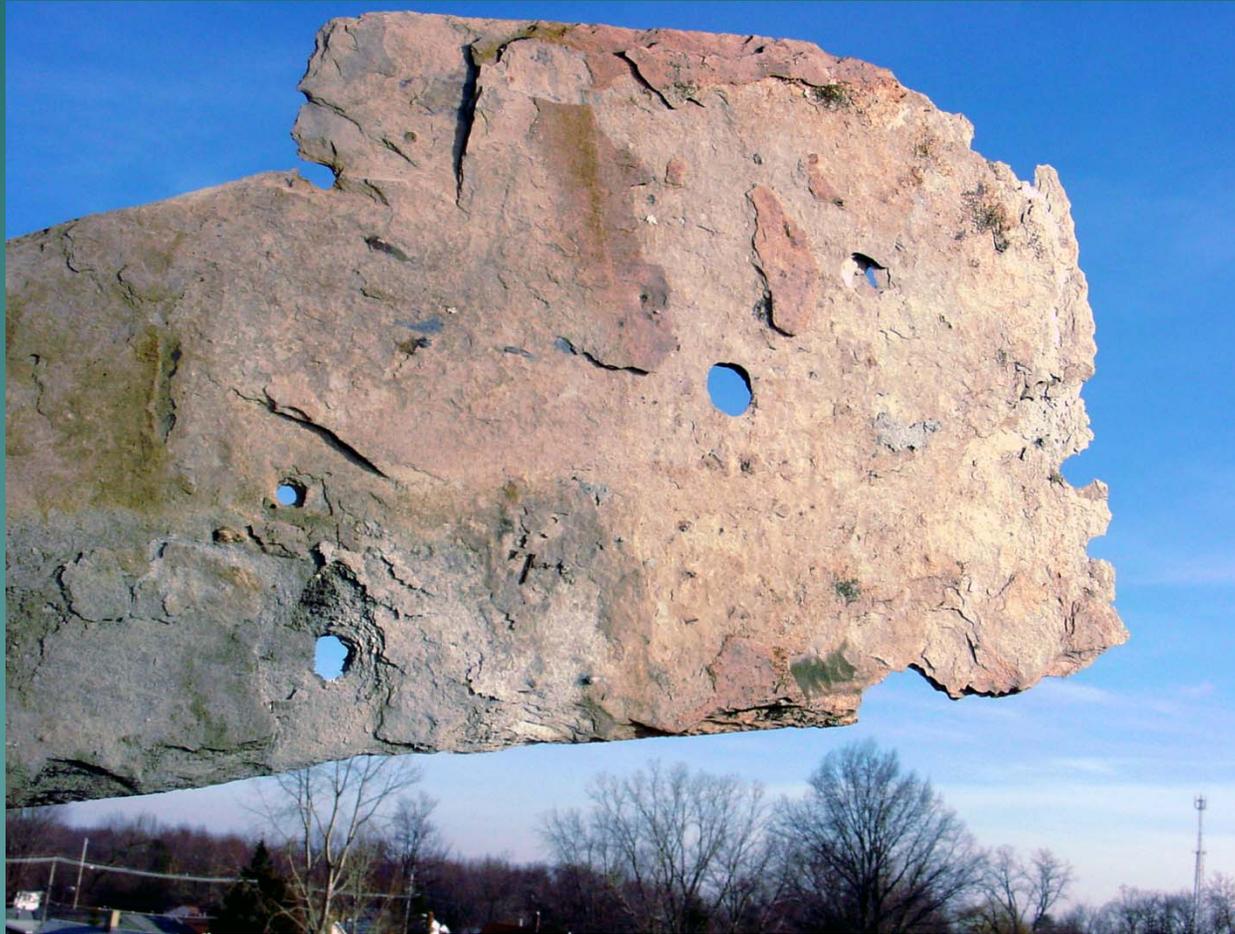
This is the front of the same slate.

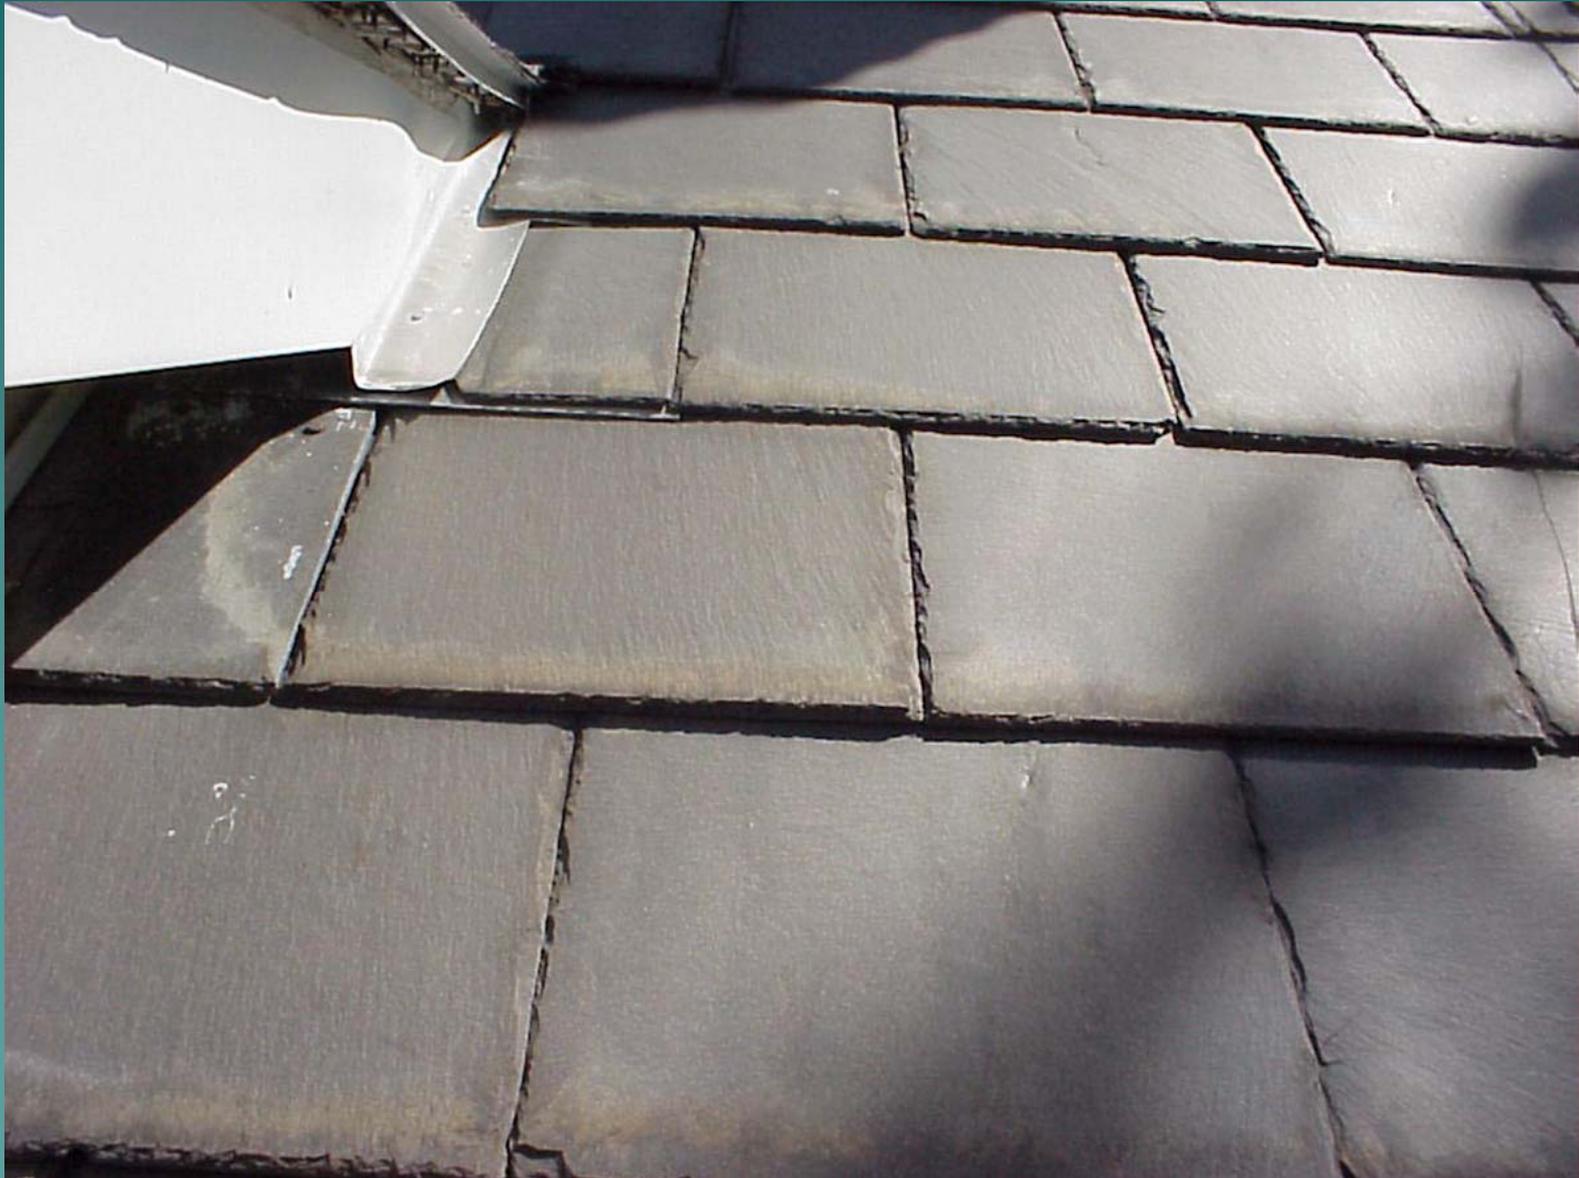
A smooth surface indicates a good slate and a good roof, no matter how old.

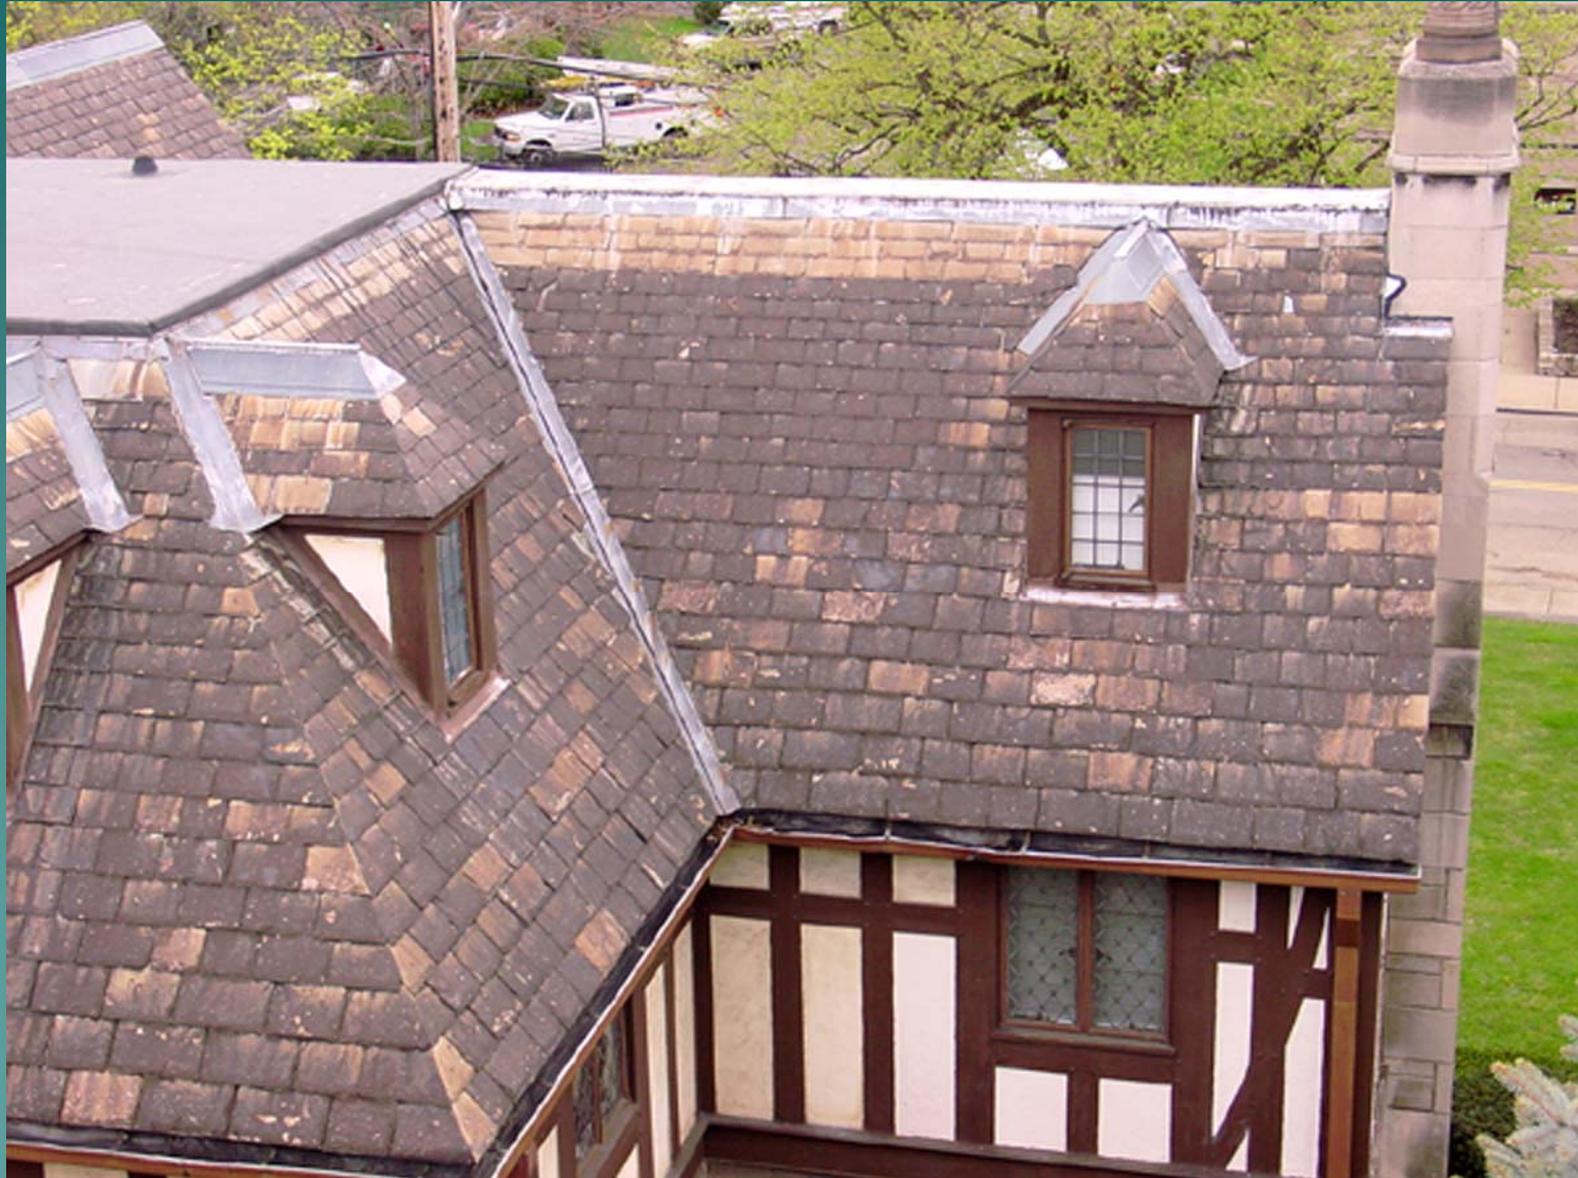
Weathering VT slate can last
150 years or longer.

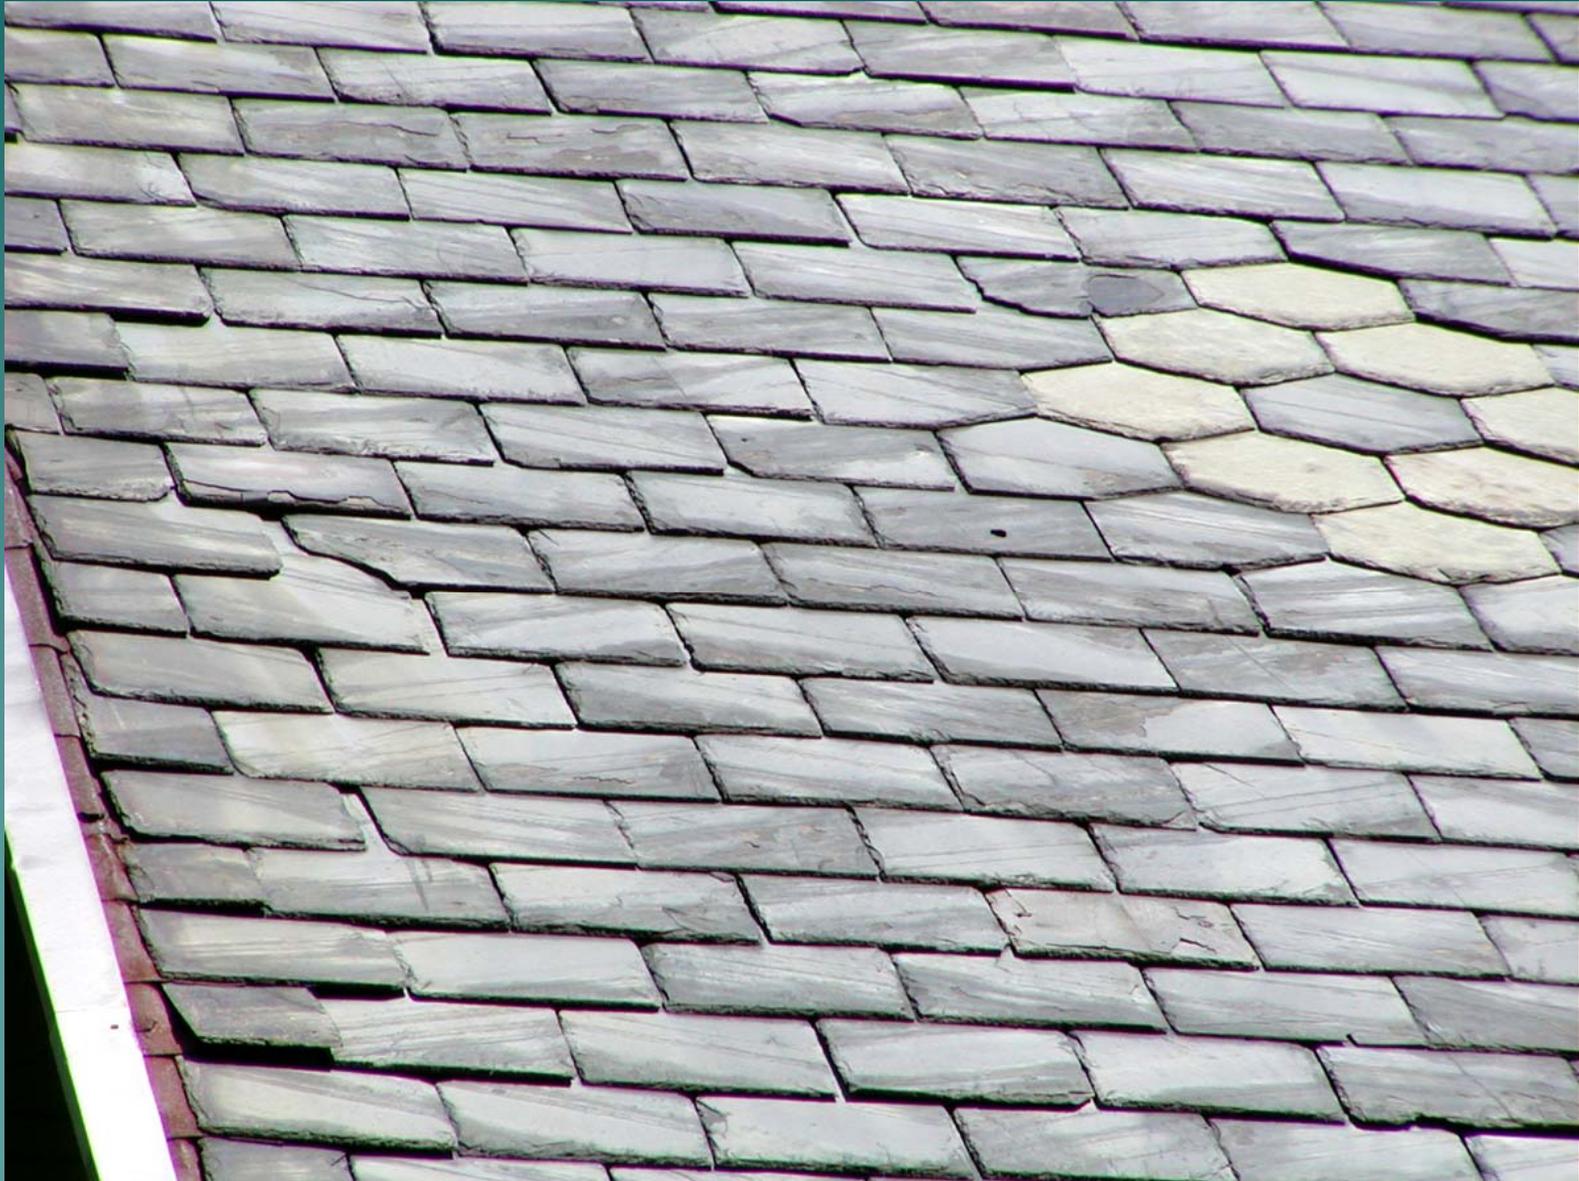
Chapman (PA) slate may last 125 years. VT unfading green may last 200 years.
