Traditional American Slate Roofs

Their Anatomy, Maintenance and
Repair

By Joe Jenkins

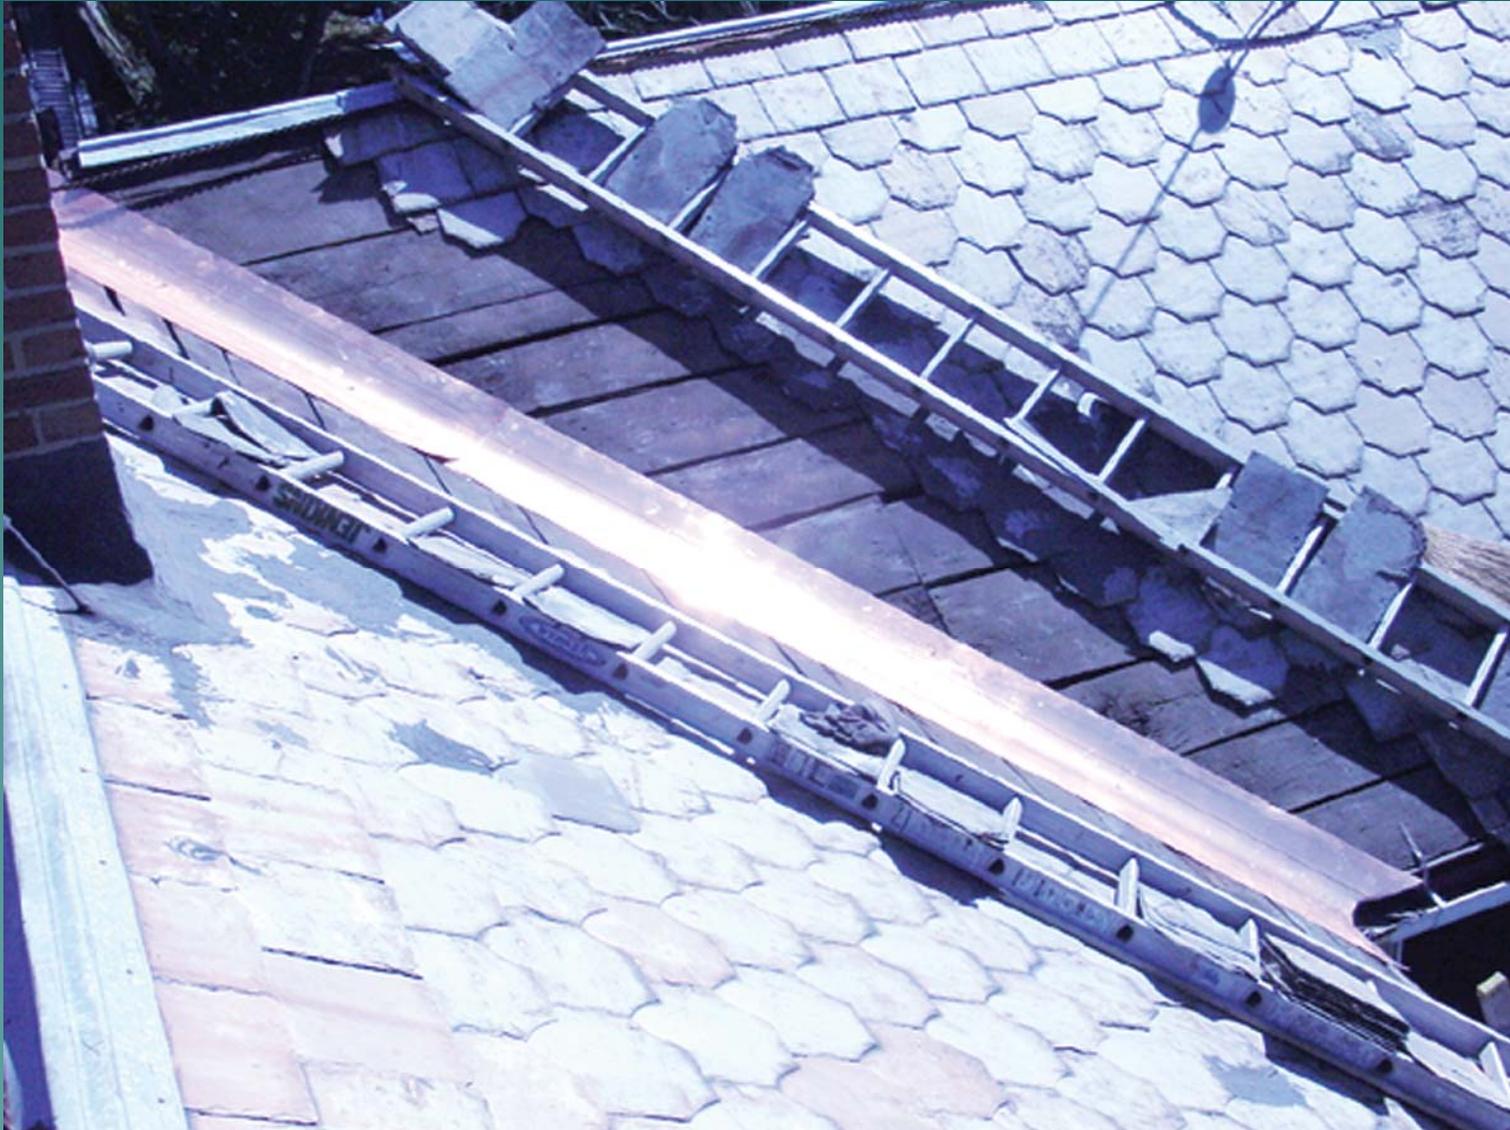
All flashing and tarred slates are removed and new flashing installed.

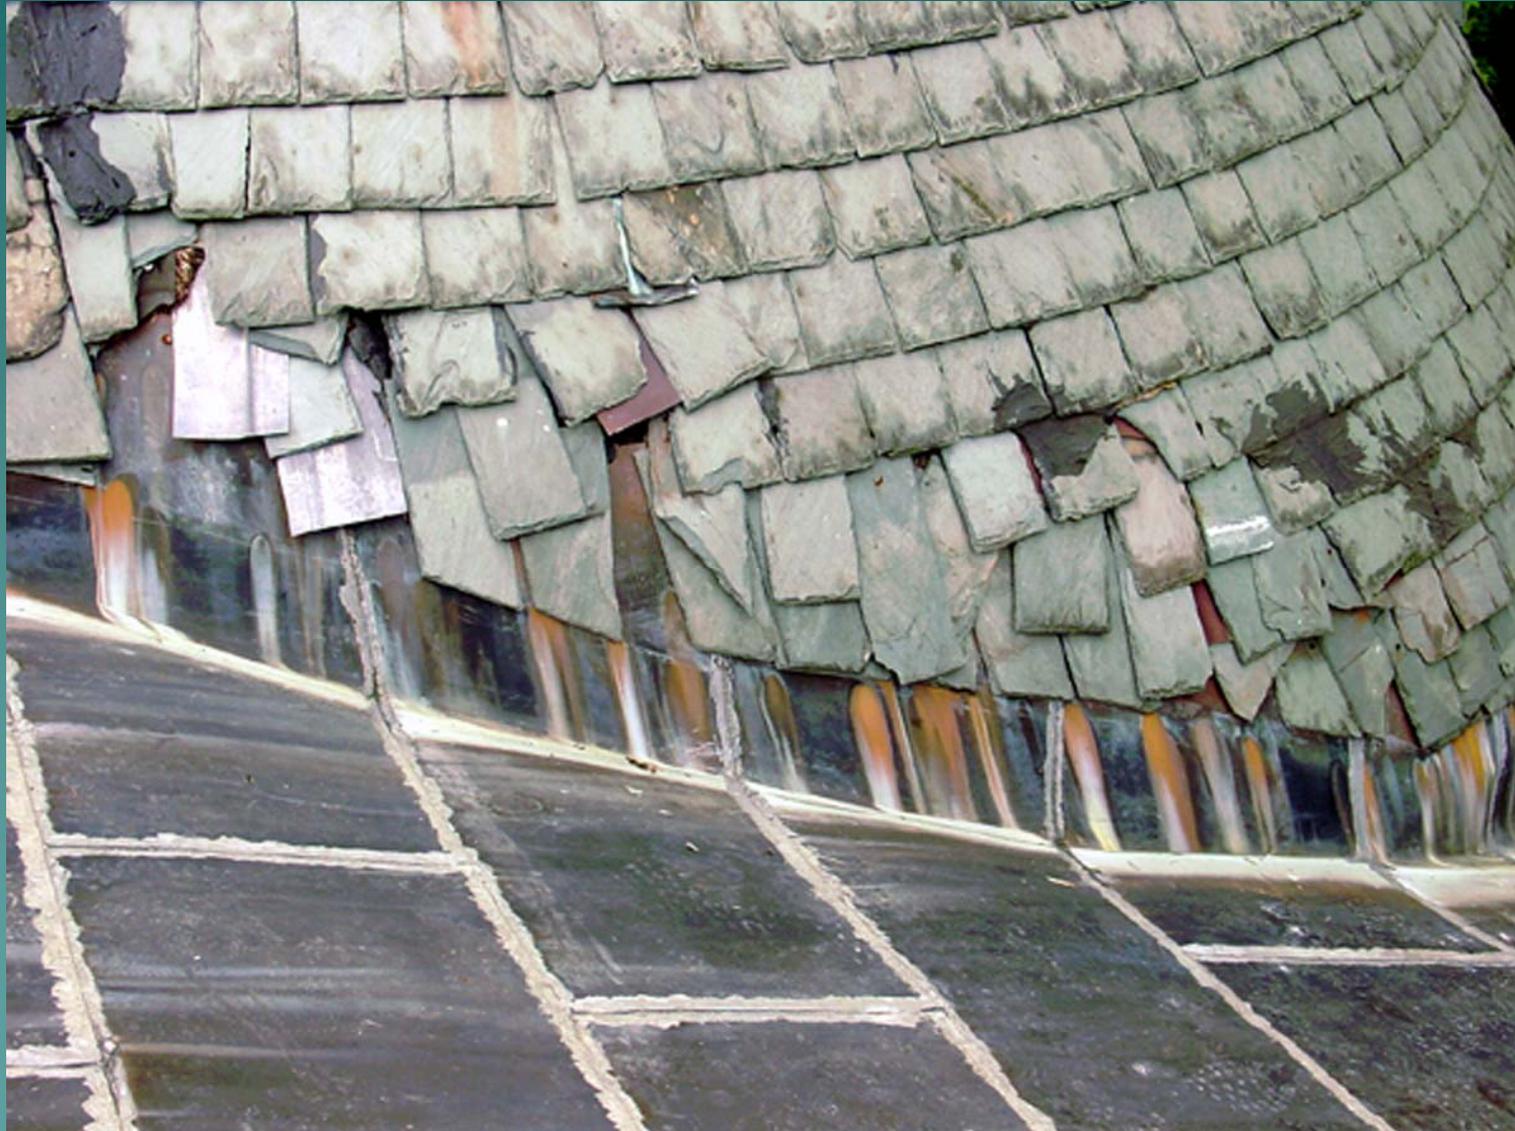
The leakage was caused by poor workmanship.

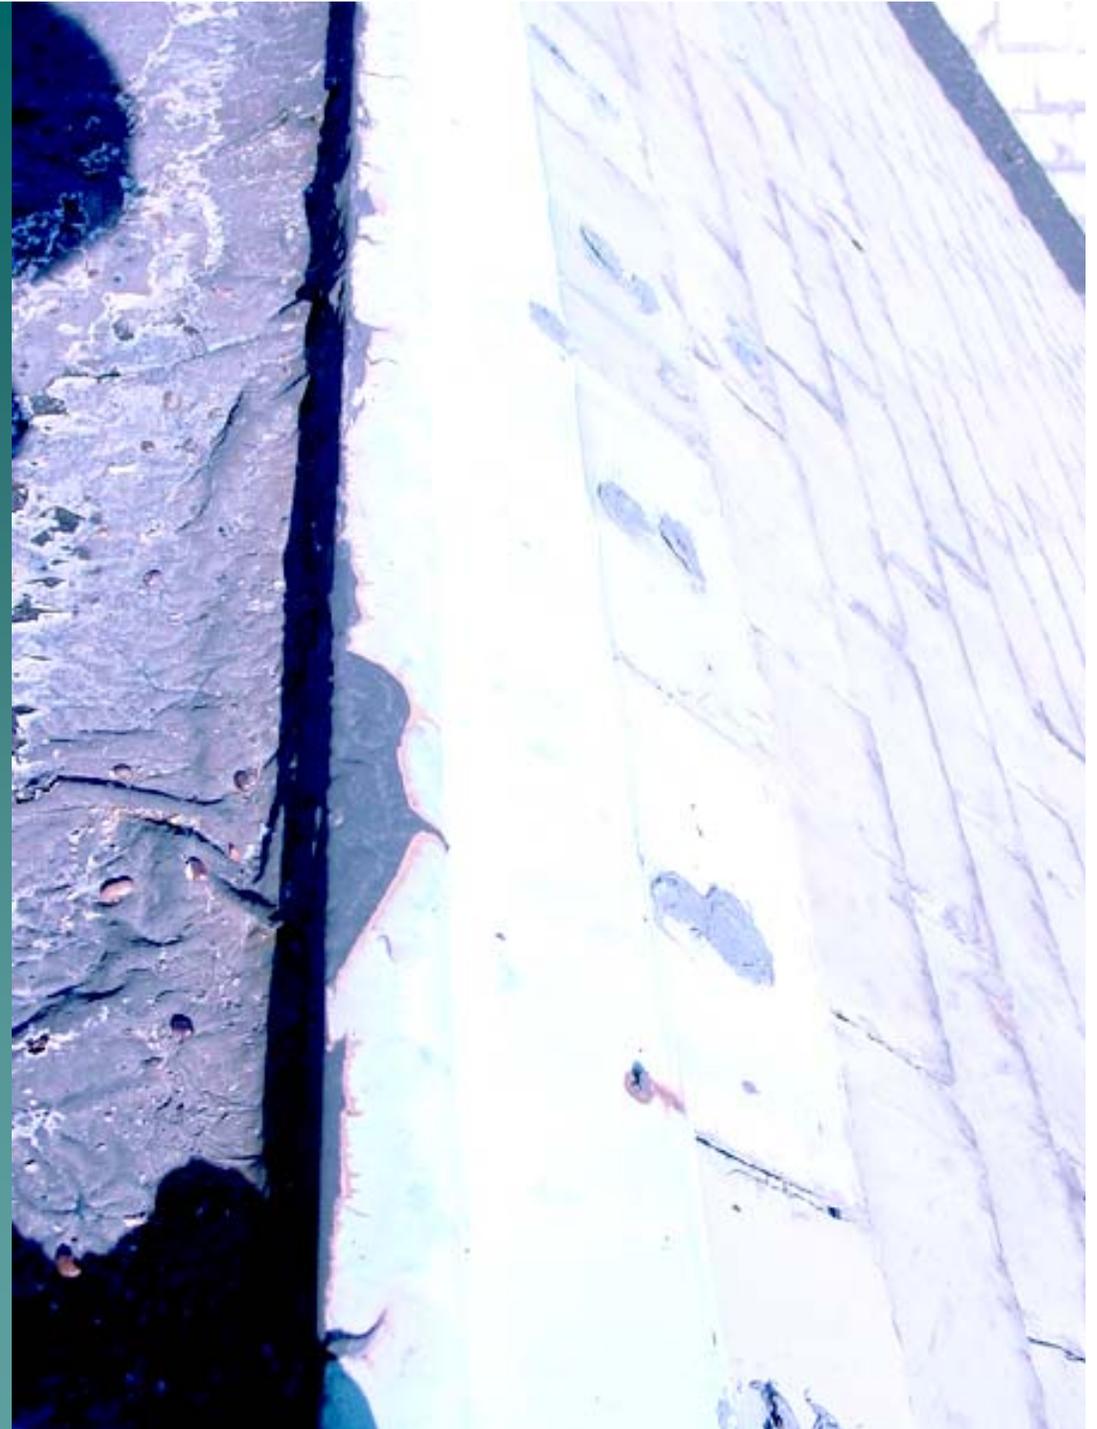
No. The leakage was not in the slate roof but in an adjoining low slope built-up roof.

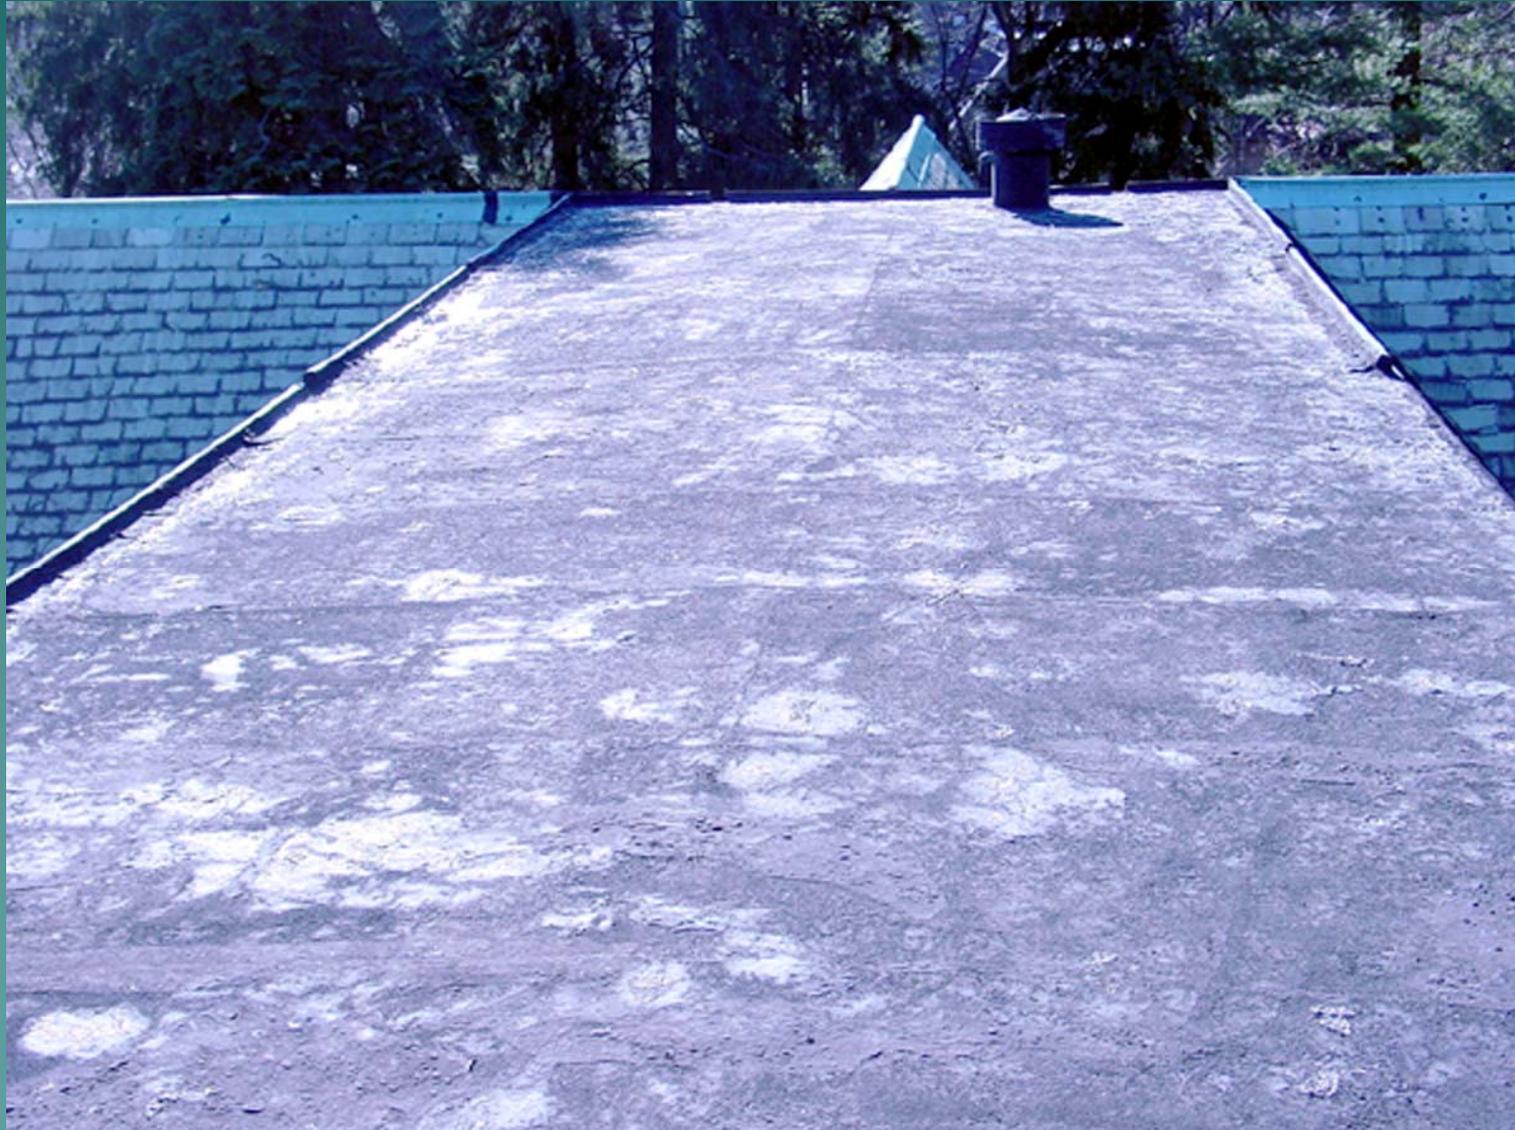
Leaking low-slope areas can be re-roofed with soldered seam metal.

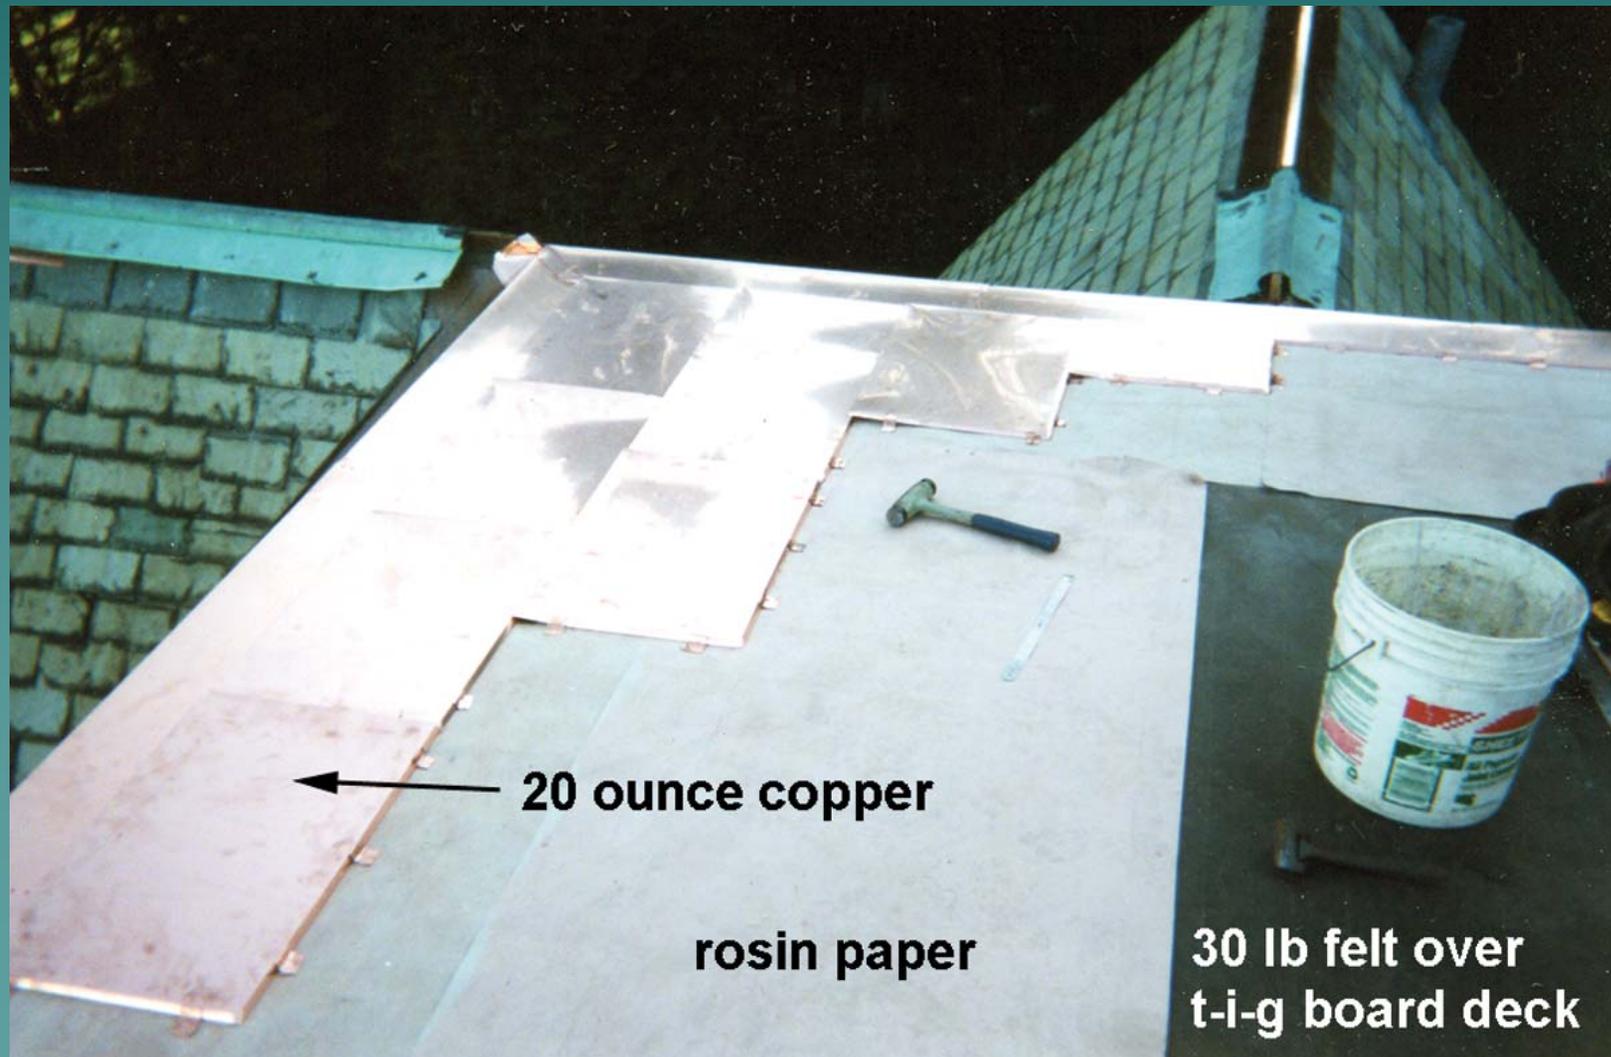
In this case, 20 ounce copper is being used.

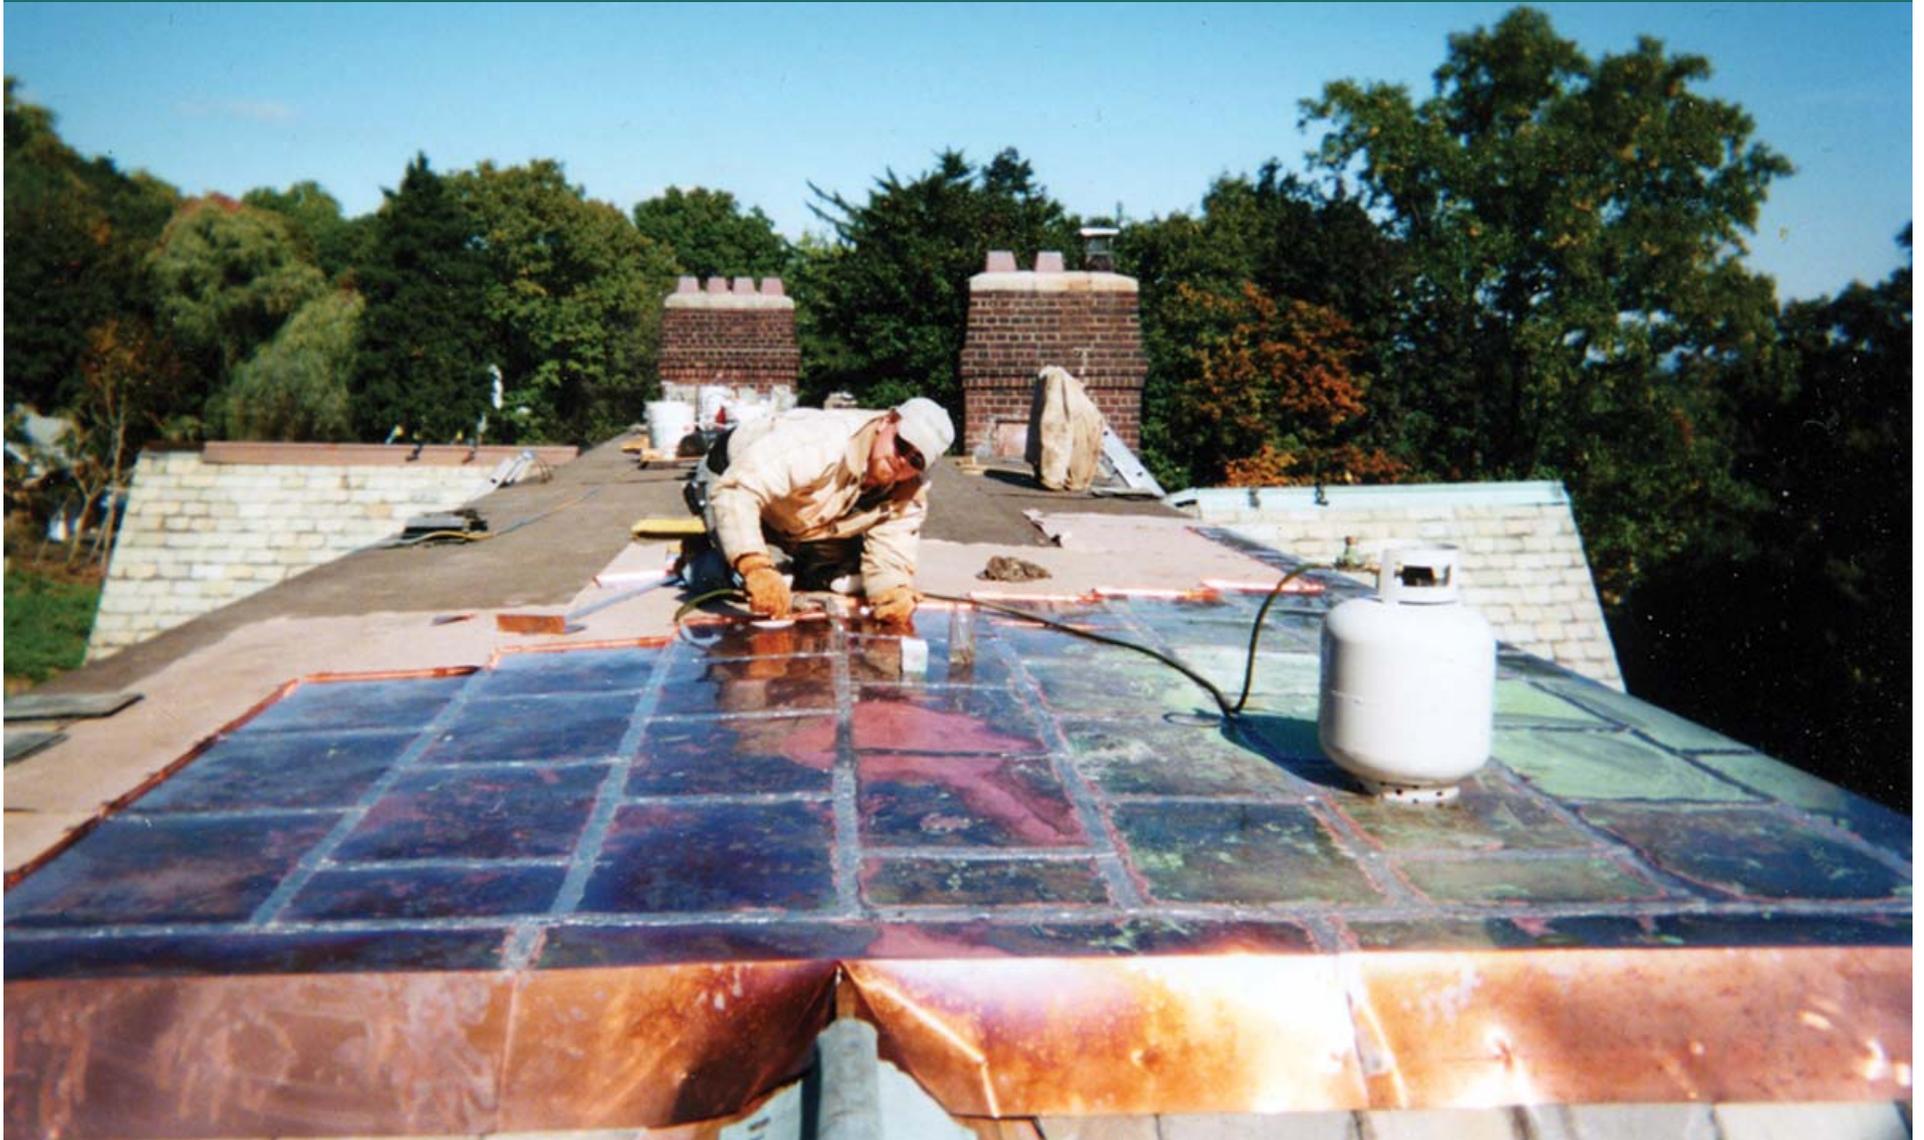
The pans are soldered together to create a durable roof.

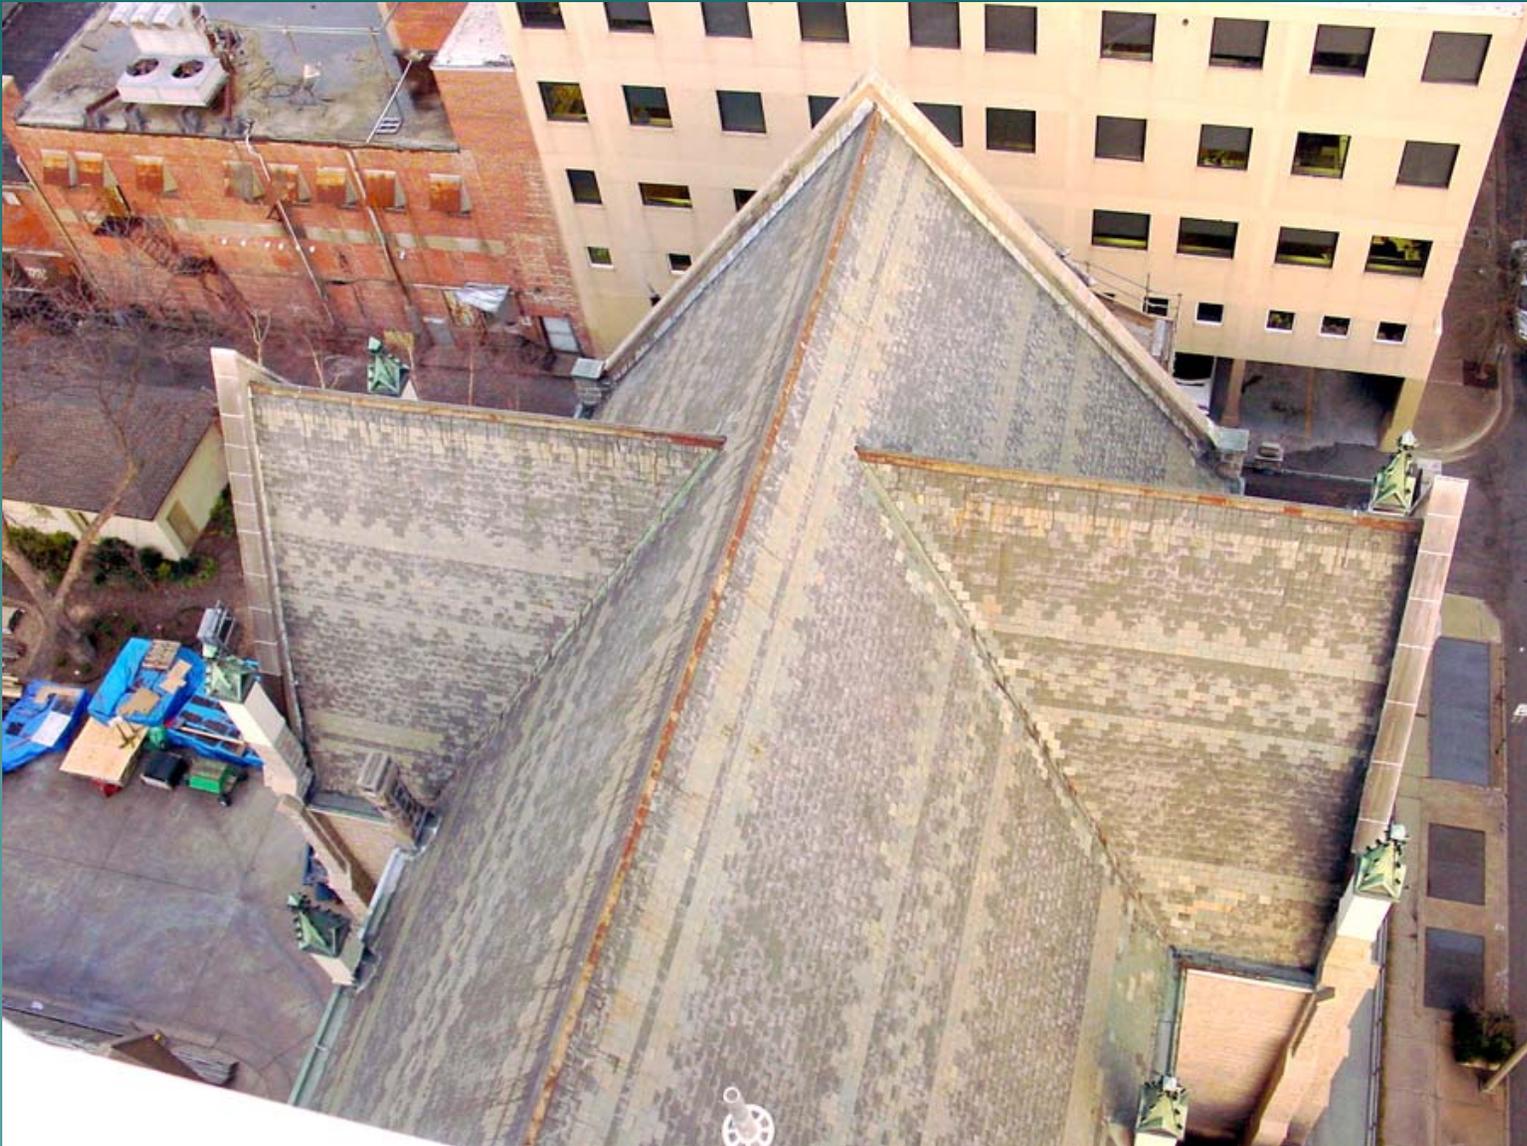
The black slates had worn out, although the green slates were still good after 120 years.

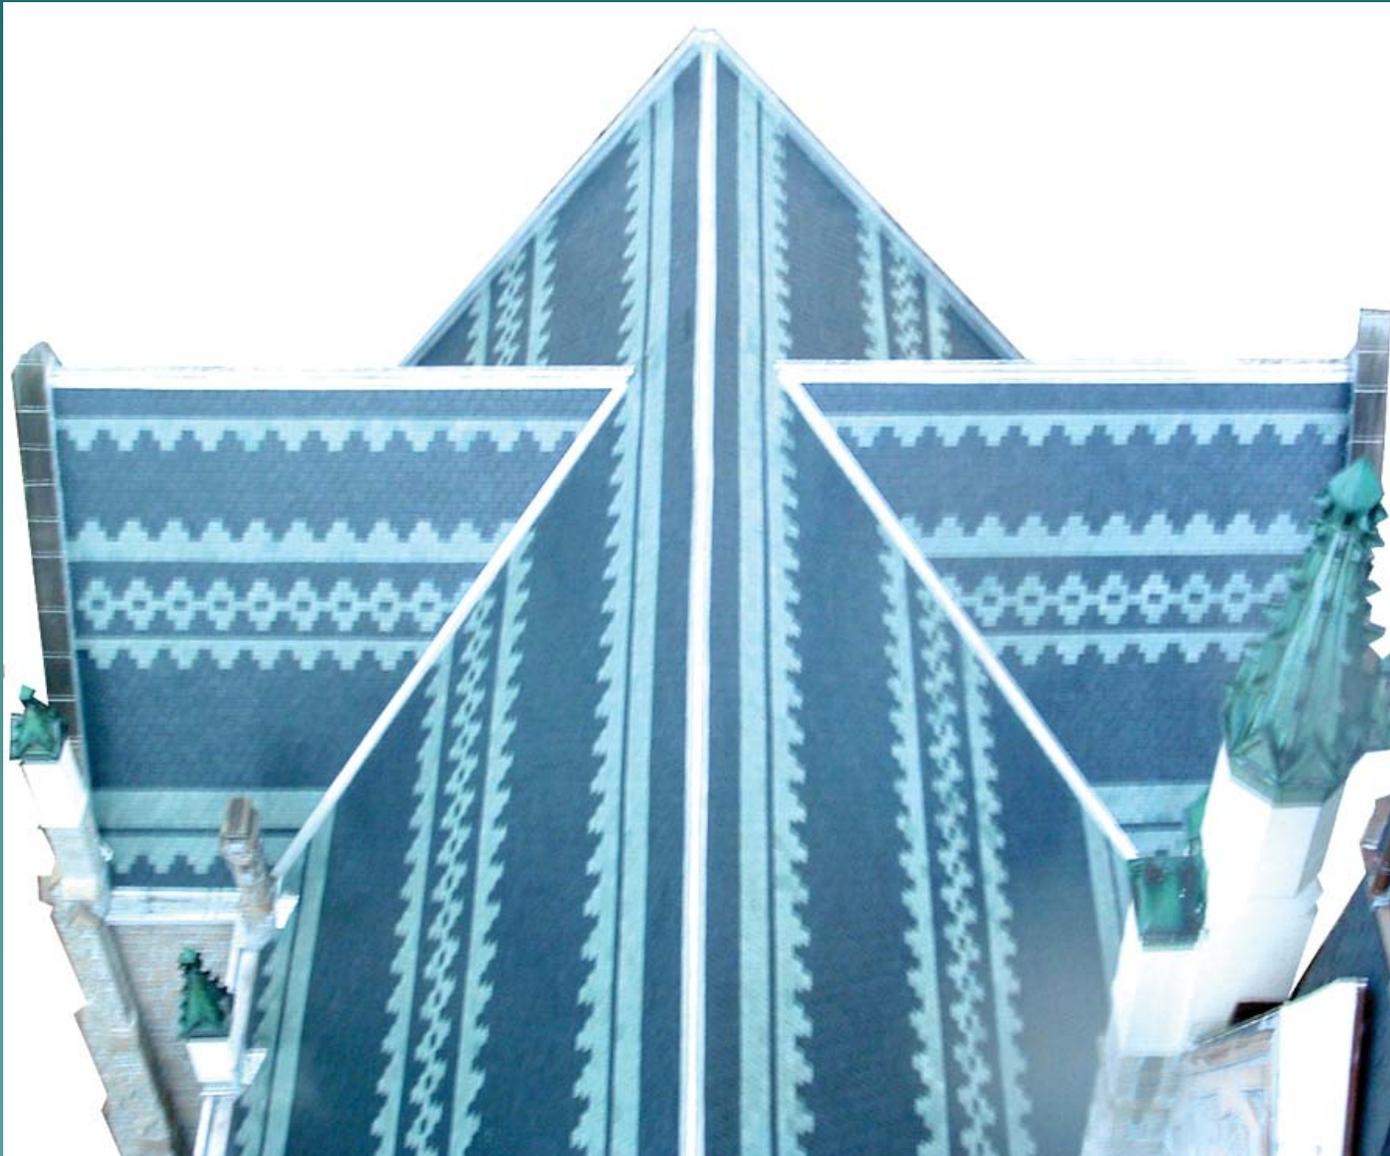
New slates and stainless steel flashings have added 150 years to this building.
