# HOW TO SURVEY A SLATE ROOF

*This paper was prepared for the Roof Consultant's Institute 2013 Conference  
Joseph Jenkins, Joseph Jenkins, Inc., SlateExperts.com*

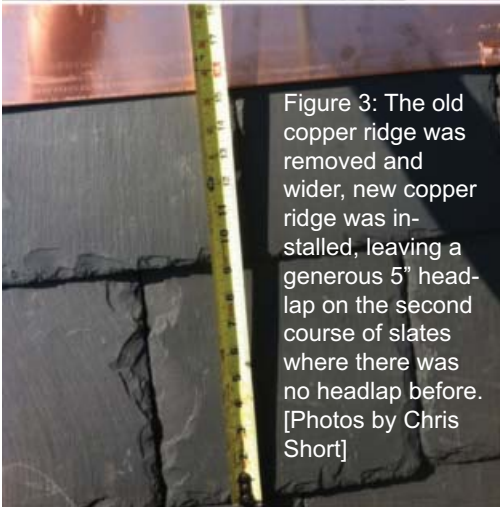
Figure 3: The old copper ridge was removed and wider, new copper ridge was installed, leaving a generous 5" headlap on the second course of slates where there was no headlap before. [Photos by Chris Short]

enough to adequately cover the slates (Figure 3), and then install the ridge without exposed fasteners by using 40 ounce copper straps (Figure 4). The lightning protection system was then attached to the copper ridge with soldered fasteners (Figure 5). This corrected the ridge installation and stopped the leakage. The consultant's opinion that the ridge joints should have been soldered together was mistaken because ridge metal is typically only overlapped, not soldered. This allows for expansion and contraction of the metal. The use of self-adhesive underlayment is a temporary band-aid solution often resorted to by persons who want to stop a leak, but aren't sure what's causing it. For more information about cleating copper ridge to a roof, see my article in Traditional Roofing #8 at TraditionalRoofing.com.

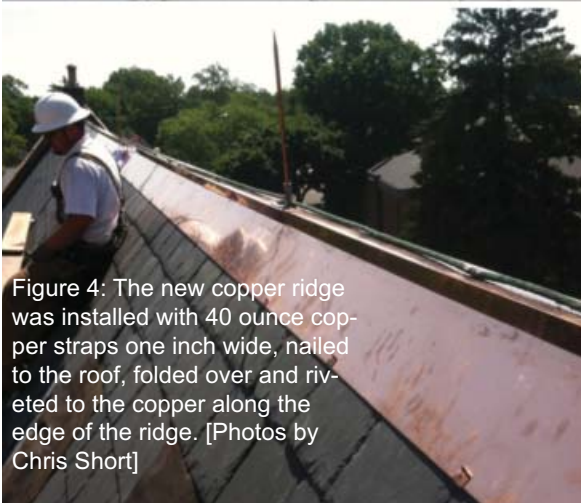
Figure 4: The new copper ridge was installed with 40 ounce copper straps one inch wide, nailed to the roof, folded over and riveted to the copper along the edge of the ridge. [Photos by Chris Short]

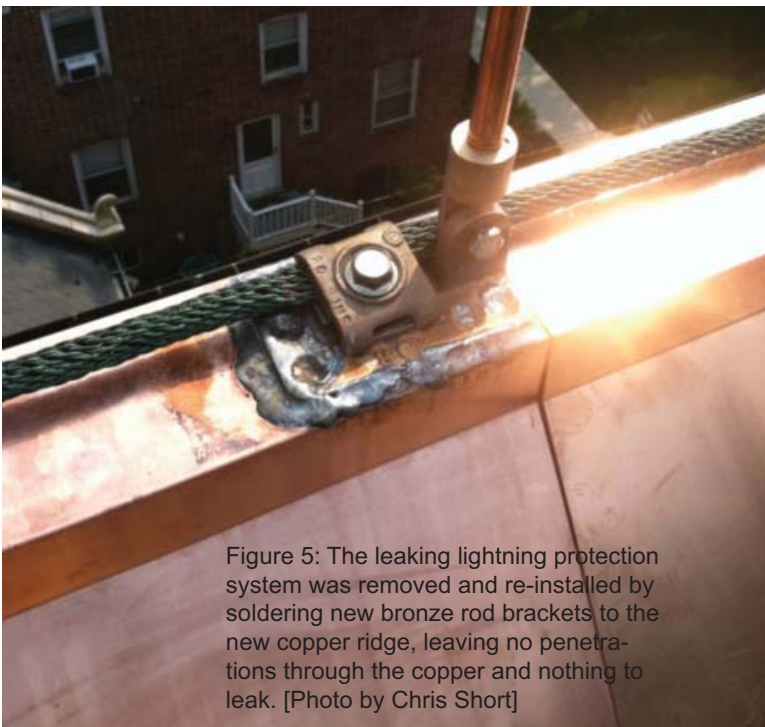
Figure 5: The leaking lightning protection system was removed and re-installed by soldering new bronze rod brackets to the new copper ridge, leaving no penetrations through the copper and nothing to leak. [Photo by Chris Short]

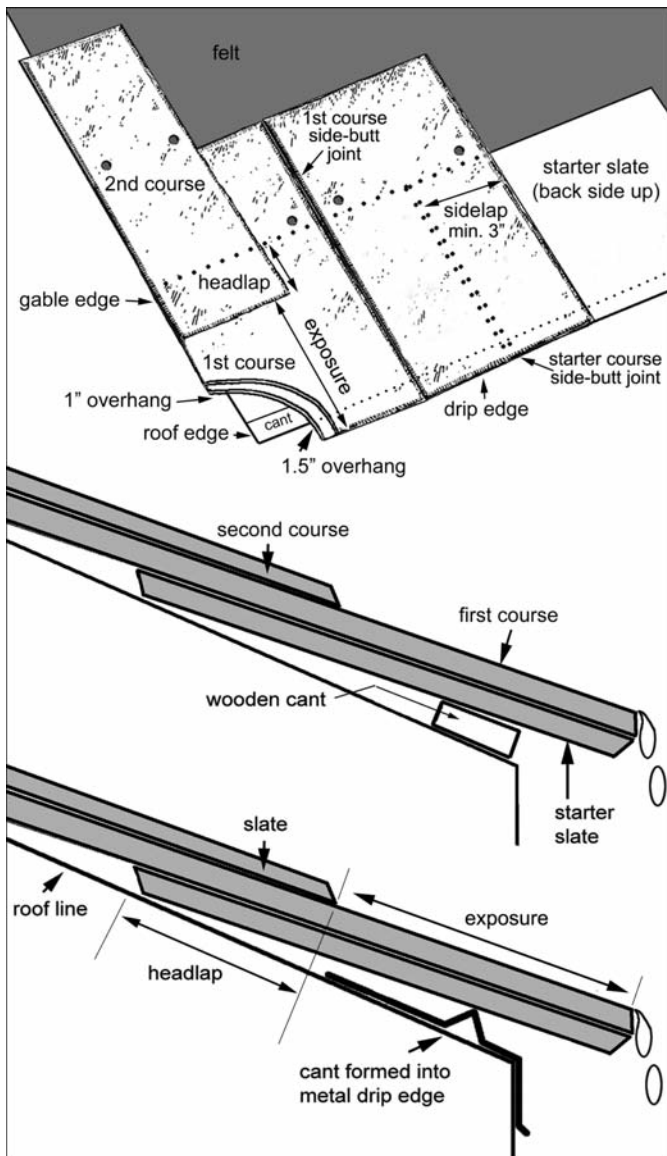
Figure 6: These diagrams from the Slate Roofing Contractors Association show the starter course, first course, second course, wood cant, metal cant, sidelap, exposure, headlap and butt joints.

really see it; only the bottom edge is exposed. But here is a good place to determine how much experience a roofer has with slate. As you climb the ladder or examine the roof on a lift, the first place you reach is the eaves. Is the starter course laid back-side-up as it should be? If not, you can expect to see errors on the remaining roof caused by inexperience. The SRCA has a handy diagram in its guidelines showing these details (Figure 6).

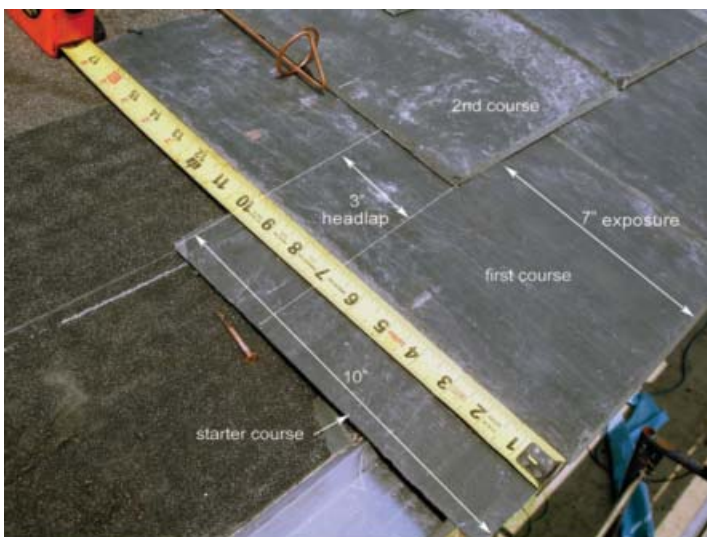
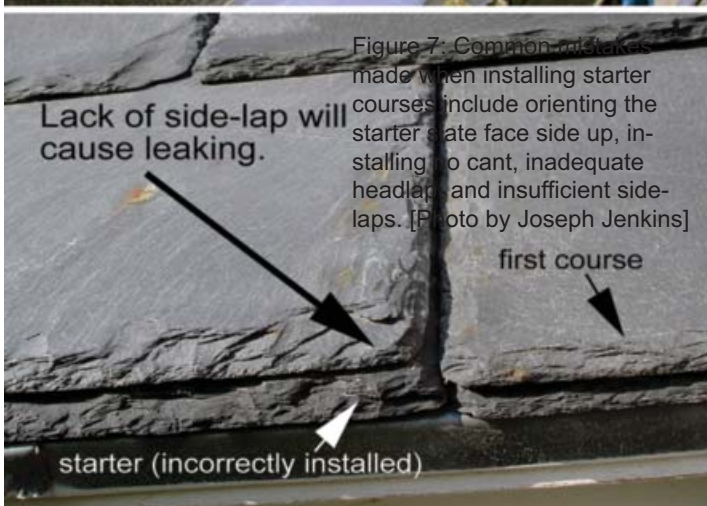
Figure 7: Common mistakes made when installing starter courses include orienting the starter slate face side up, installing no cant, inadequate headlap, and insufficient side-laps. [Photo by Joseph Jenkins]

Figure 7: Common mistakes made when installing starter courses include orienting the starter slate face side up, installing no cant, inadequate headlap, and insufficient sidelaps. [Photo by Joseph Jenkins]

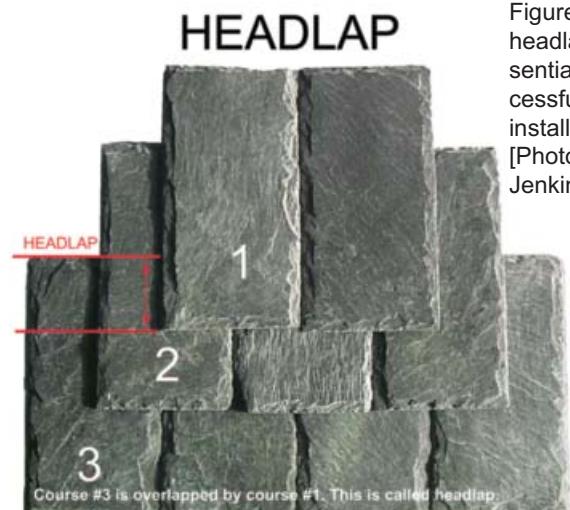
Figure 8: Correct headlap is essential for a successful slate roof installation. [Photo by Joseph Jenkins]

One of the most grievous errors on slate roofs is inadequate headlap, which can condemn an entire roof no matter how new or how nice the slates are (see Figure 8). In standard American slate roof

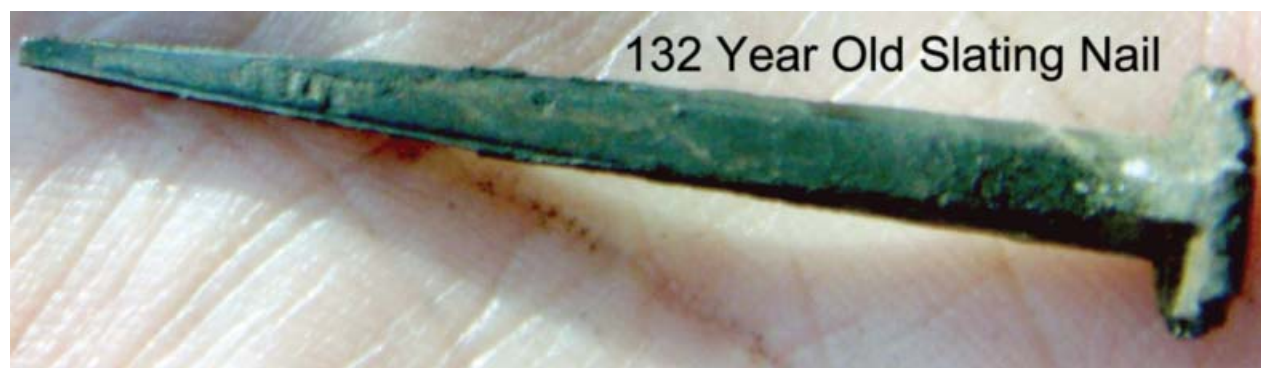
Figure 9: Just because the roof is old doesn't mean the nails have gone bad. This steel slating nail was pulled off a Buckingham slate roof on an 1879 church in Virginia in 2011. [Photo by Joseph Jenkins]

In the United States, most of the older roofs fall into the 100-130 year age bracket. Nails tend to be well-preserved underneath hard slates on older roofs. Figure 9, for example, shows a slating nail that is 132 years old removed from a Buckingham slate roof on a church in Virginia. Note that it shows virtually no deterioration despite the age. You will often hear people insist that an older slate roof must be replaced because of nail failure. This is rarely true and is only likely to happen when the slate itself has turned soft and is allowing moisture through into the nails. It's also possible on barn roofs where the underside of the nail is exposed to the interior where it protrudes through the roof deck. Condensation over a long period of time will rust the nail from the bottom up. Otherwise, nails do not deteriorate underneath hard slates unless water or moisture can get to them.

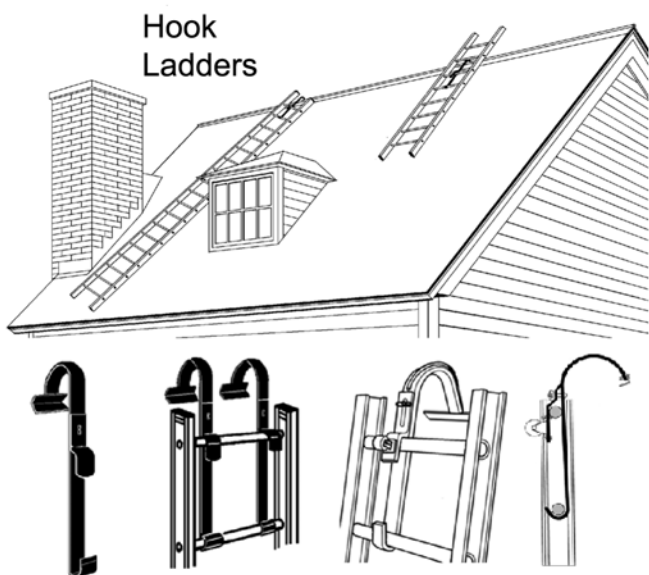
Figure 10: Hook ladders come in handy when accessing steep roofs.

How do you get on a slate roof? First, wear soft-soled shoes such as tennis shoes. Do not wear hard-soled work boots. Avoid walking on the roof. If you have to move about on the slates, crawl around on all fours keeping your distributed weight on the open faces of the slates. You can usually walk upright in the valleys, hips and ridges without worrying about damaging them, so these are the preferred walkways. Hook ladders (Figure 10) are essential at times when you just can’t get at a roof area any other way.

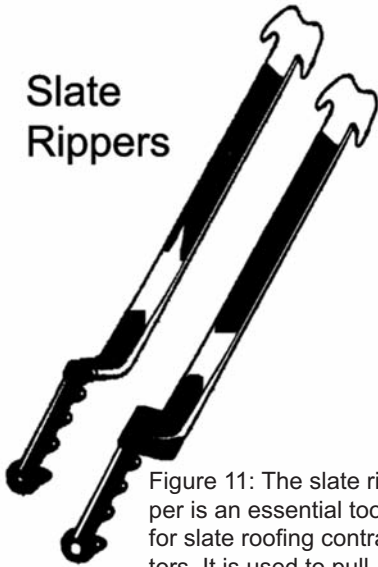
Figure 11: The slate ripper is an essential tool for slate roofing contractors. It is used to pull out the nails that hold a slate in place, thereby allowing the slate to be slid out.

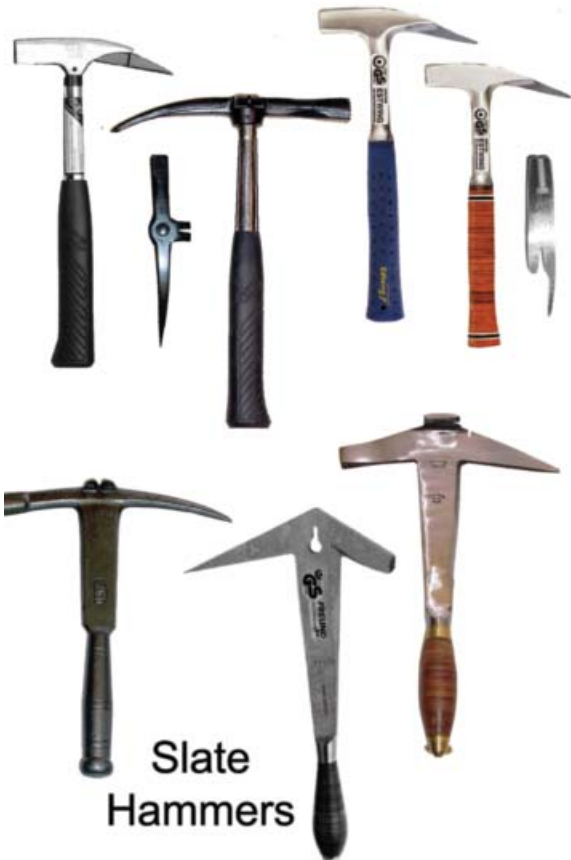
Figure 12: Slate hammers come in a variety of shapes and styles. They all have a pointed pick end that is used to punch nail holes in slates.

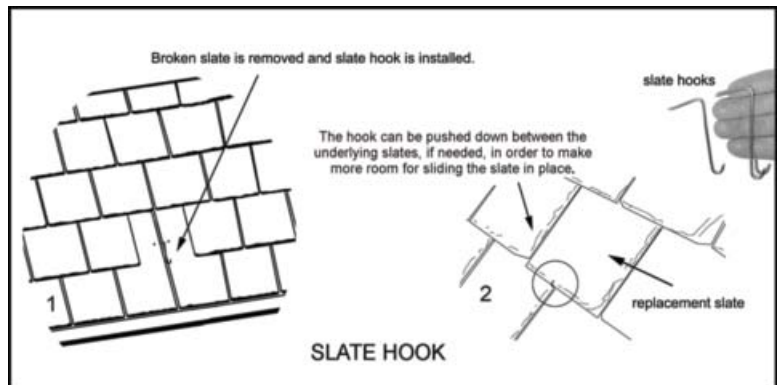
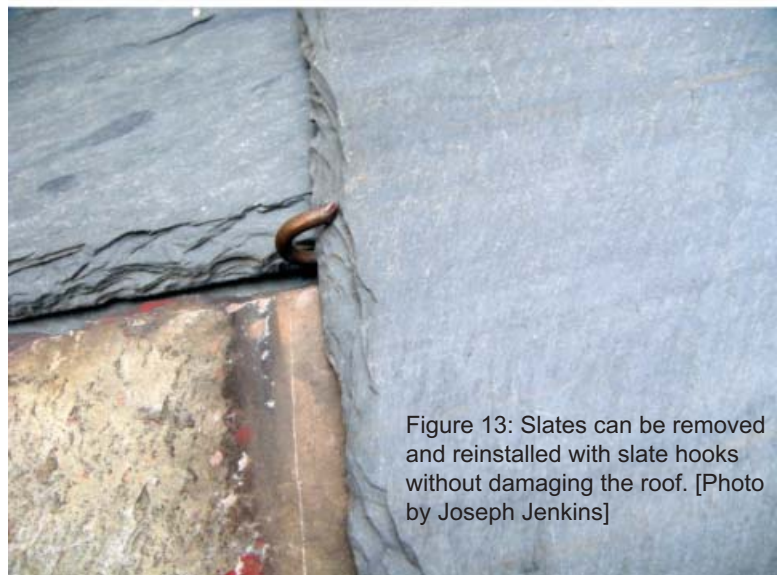
Figure 13: Slates can be removed and reinstalled with slate hooks without damaging the roof. [Photo by Joseph Jenkins]

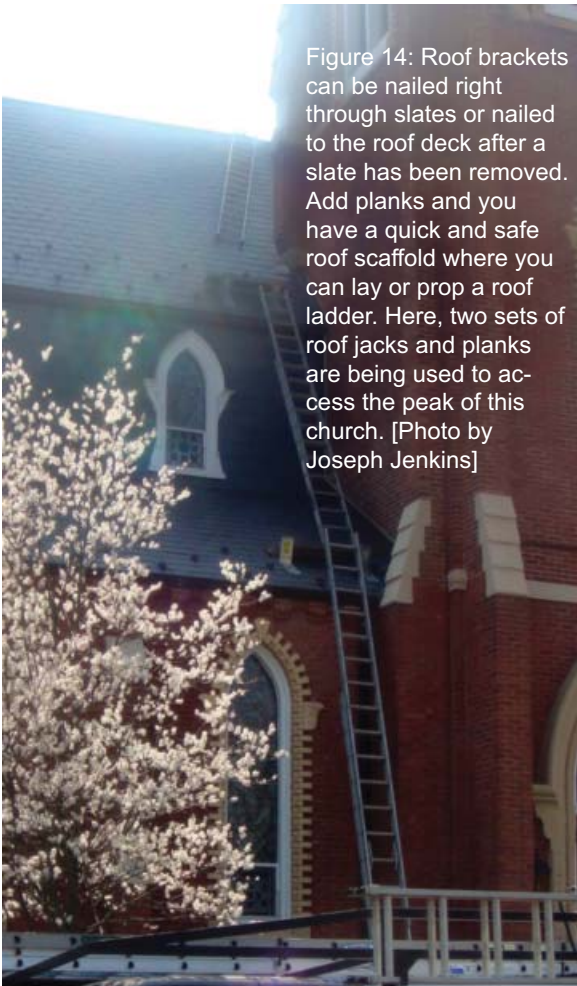
Figure 14: Roof brackets can be nailed right through slates or nailed to the roof deck after a slate has been removed. Add planks and you have a quick and safe roof scaffold where you can lay or prop a roof ladder. Here, two sets of roof jacks and planks are being used to access the peak of this church. [Photo by Joseph Jenkins]

Of course, if you're driving to a site and have a truck with ladders, you should have all the tools you need, including hook ladders and roof brackets. Roof brackets, also called roof jacks, nail into a roof and provide a support for planks, thereby creating a roof scaffold. You can nail them right through the slates in the space between the shingles, then remove them and slide a metal flashing under the slates but over the holes. Alternatively, you can remove a slate and then nail the bracket between the underlying slates. Then you simply remove the bracket and replace the slate with a slate hook. You can stand on these roof scaffolds or place single section ladders on them by laying the ladder flat on the roof with the feet on the plank. These techniques will enable you to reach almost any place. Figure 14 shows roof jacks, planks, a roof ladder and a hook ladder utilized to reach the peak of a church roof behind the bell tower. There was no other easy way to reach the top of this 16:12 peak. I should add that there are quite a few slate roofing videos on YouTube, especially at the channel jenkins01. You can see the roof brackets being removed and the bib flashing being installed on this church there, for example.

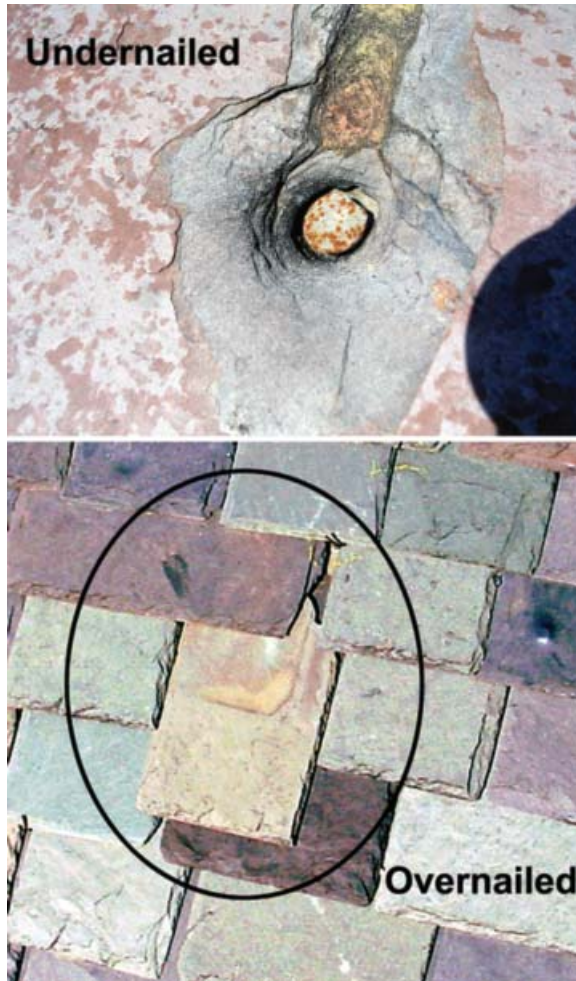
Figure 15: Under-nailed slates aren't driven in far enough, leaving a protruding nail head to rub against the overlying slate, eventually to wear a hole in it. Over-nailed slates become broken when the nail is driven through the slate. [Photos by Joseph Jenkins]

Figure 15: Undernailed slates aren't driven in far enough, leaving a protruding nail head to rub against the overlying slate, eventually to wear a hole in it. Overnailed slates become broken when the nail is driven through the slate. [Photos by Joseph Jenkins]

Other things to look for on slate roofs are "over-nailing" and "under-nailing" of the slates. Over-nailing is when the person who is driving the nails hits the nail too hard and it punches into the slate. This tends to break out the nail hole and leave the slate fastened only with one nail. You will see slates hanging sideways when this happens. Under-nailing is when the installer doesn't drive the nail

far enough and the head sticks above the slate. The result is a nail head rubbing against the overlying slate, eventually wearing a hole in it (see Figure 15).

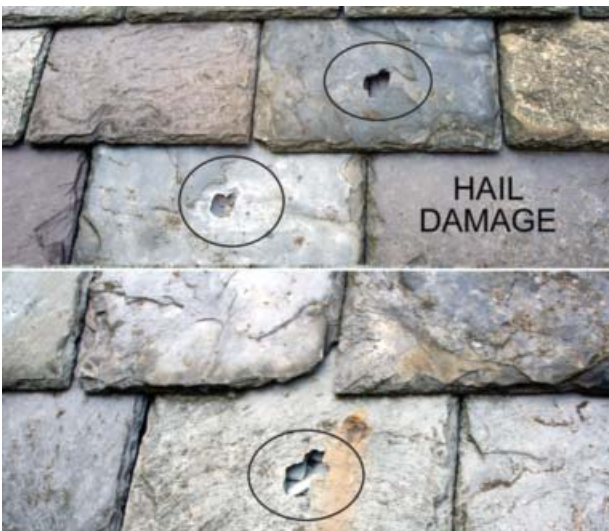
Figure 16: External punctures, such as from large hail stones, leave holes with sharp edges, as shown here. The crater is always opposite the impact side. [Photo by Joseph Jenkins]

Often, consultants are called on to determine if weather events have damaged a roof. The two primary types of damage are from hail and wind. When a slate is punctured, the back of the hole blows out, forming a crater on the side opposite the impact.

Therefore, if you are seeing holes in slates that show craters, you can be sure that the holes originated from internal pressure, such as a nail head underneath (as shown in Figure 15). Large hail stones can puncture slates, but you will not see the crater on the face of the slate (Figure 16). In the February, 2008 issue of RCI Interface, I authored an article called "What the Hail," which explains this in greater detail. It can also be downloaded at [TraditionalRoofing.com](http://TraditionalRoofing.com).
